**NIST NCSTAR 1**

# **Final Report** on the **Collapse of** **the World Trade Center Towers**

**National Institute of  
Standards and Technology**

September 2005

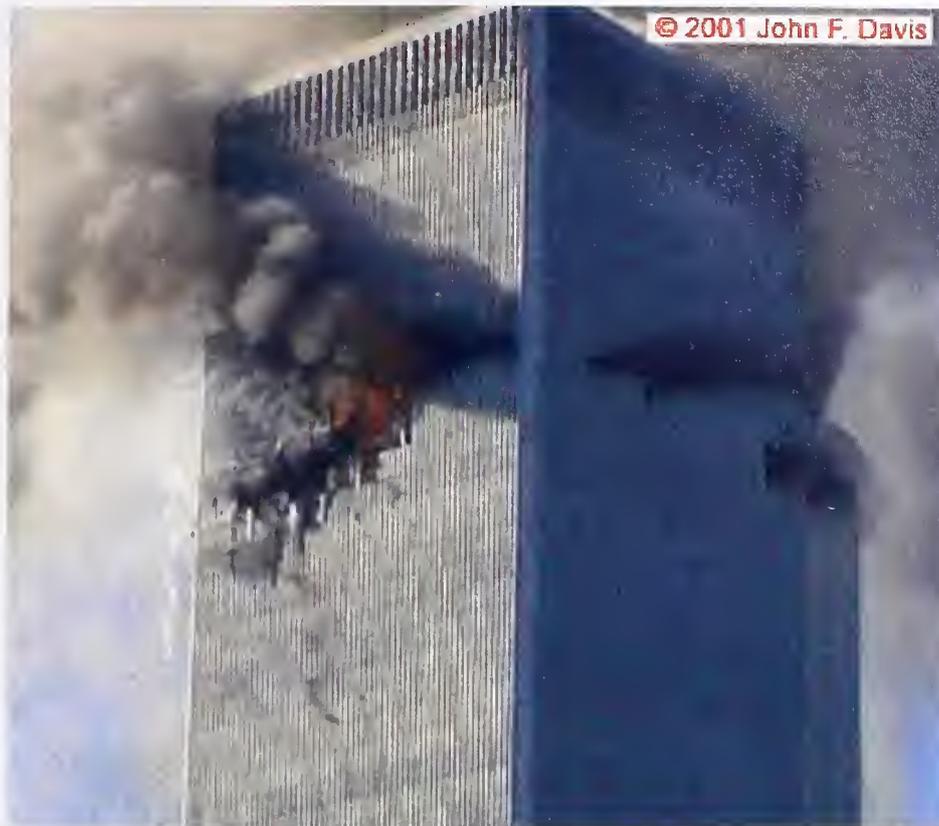
**Figure 2–2. Aircraft entry hole on the north side of WTC 1, photographed 30 s after impact.**

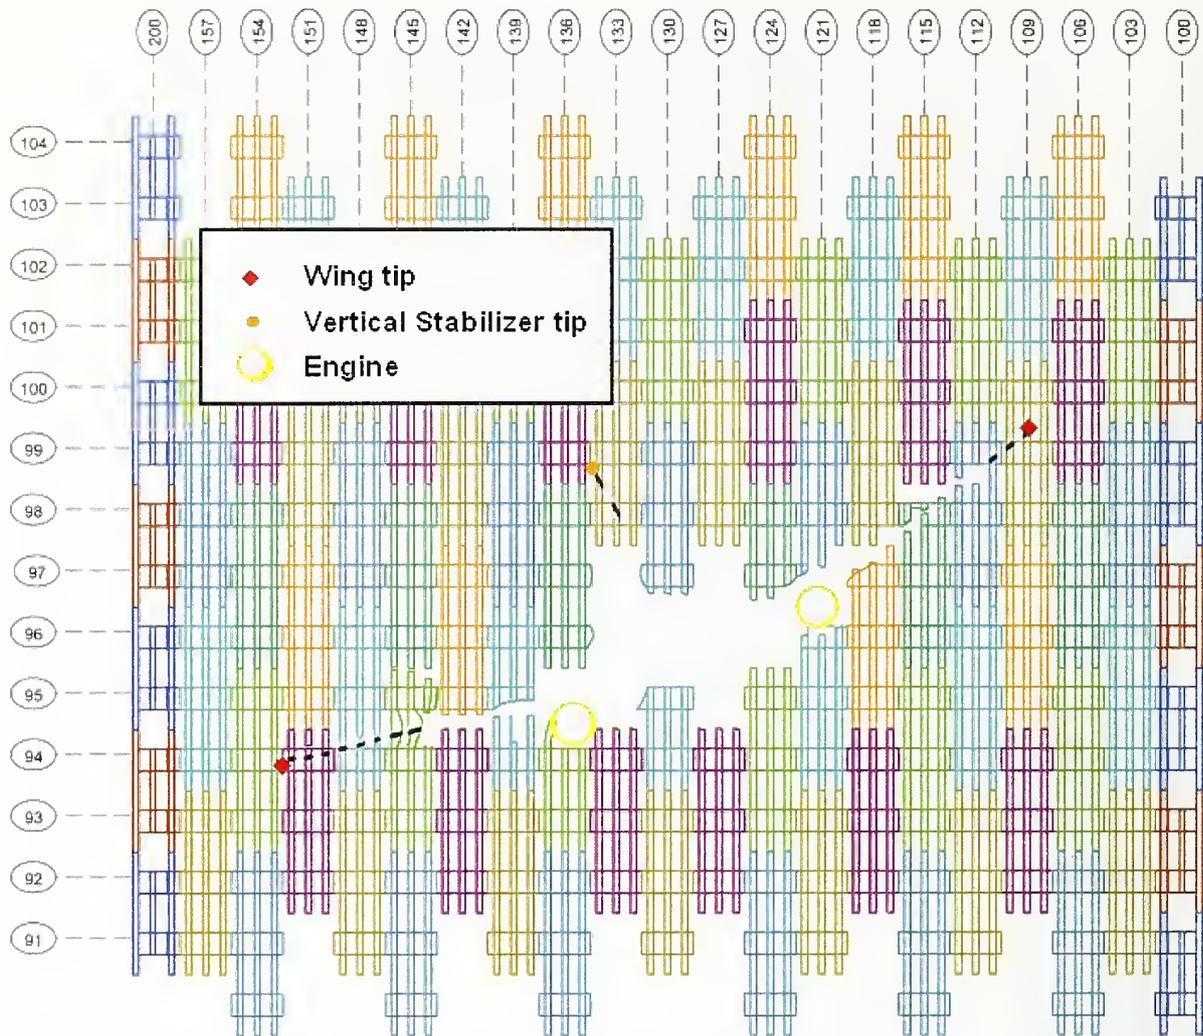
The aircraft did the most damage to the 95<sup>th</sup> and 96<sup>th</sup> floors. The fuel-heavy inner left wing hit the 95<sup>th</sup> floor slab, breaking it over the full 60 ft depth of tenant space and another 20 ft into the building core. The fuselage was centered on the 96<sup>th</sup> floor slab and filled the 95<sup>th</sup> and 96<sup>th</sup> floors top to bottom. The severity of the impact was clear. A wheel from the left wing landing gear flew through multiple partitions, through the core of the building, and became embedded in one of the exterior column panels on the south side of the tower. The impact severed the bolts connecting the panel to its neighbors, and the panel and tire landed on Cedar Street, some 700 ft to the south. A second wheel landed 700 ft further south. Within the two floors, 15 to 18 perimeter columns and five to six core columns were severed, and an additional one to three core columns were heavily damaged. A 40 ft width of the 96<sup>th</sup> floor slab was broken 80 ft into the building. The insulation was knocked off nearly all the core columns and over a 40 ft width of floor trusses from the south end of the core to the south face of the tower.

**Figure 2–3. South face damage of WTC 1 with key aircraft component locations marked.**

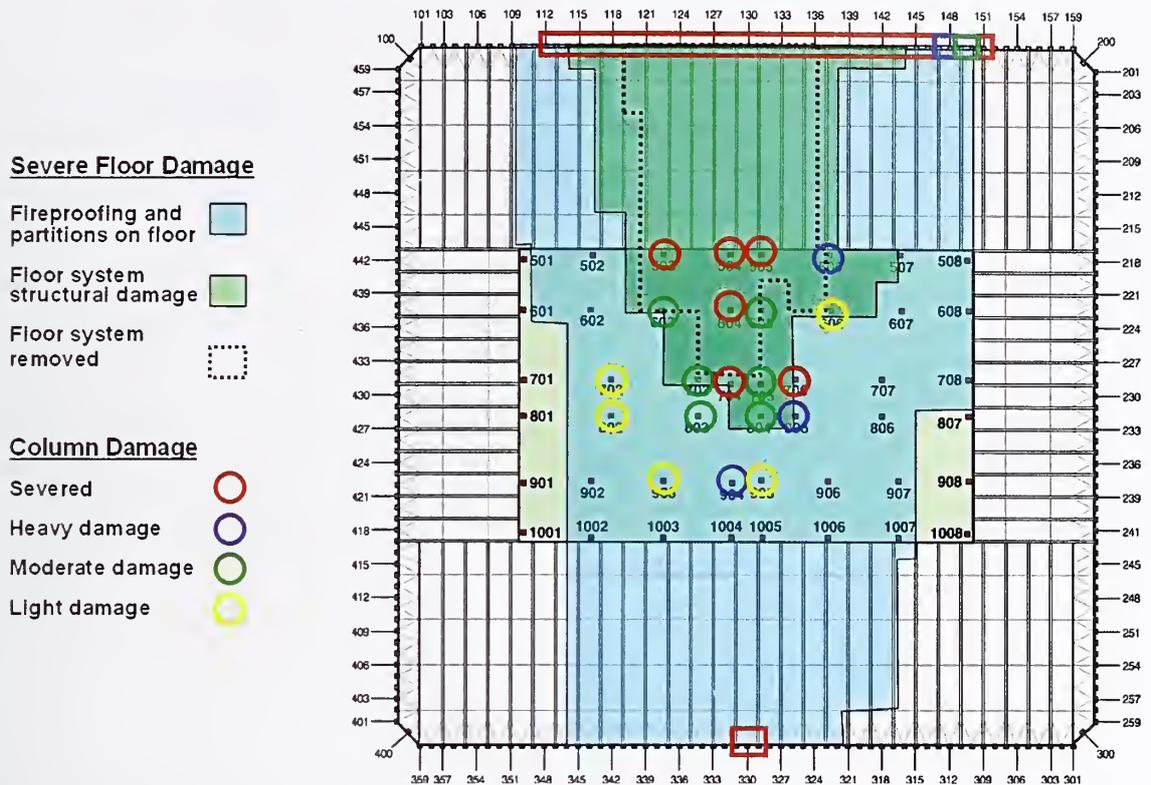
- 43 of 47 core columns stripped of insulation on one or more floors.
- Insulation stripped from trusses covering 60,000 ft<sup>2</sup> of floor area.

**Figure 2–4. Simulation of cumulative aircraft impact damage to floors 93 through 98 in WTC 1.**

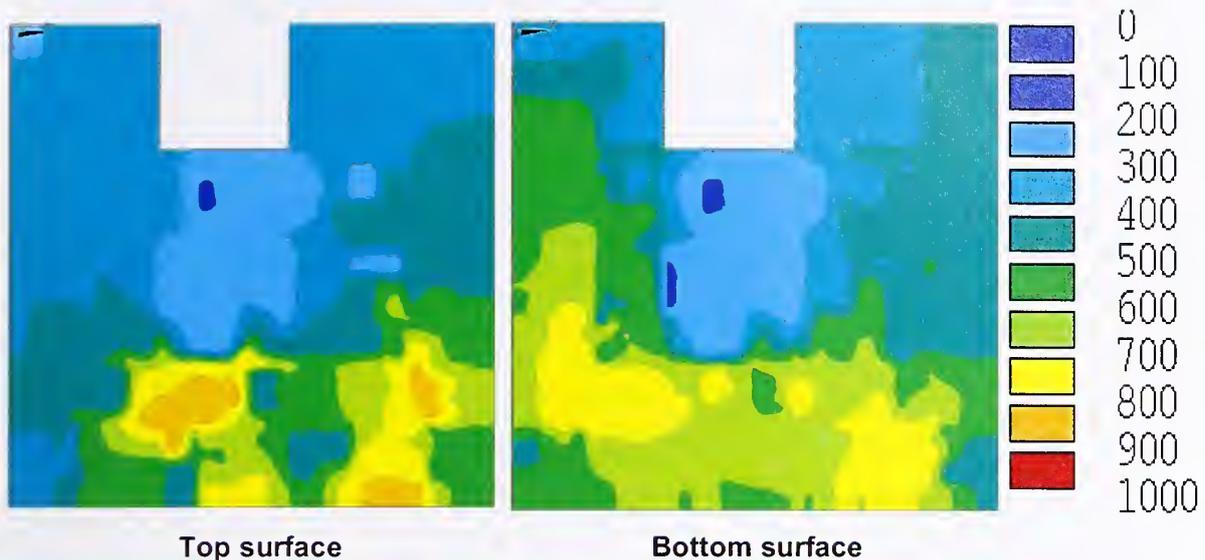
Simultaneously, the fires were creating another problem for the tower. The floors of the 93<sup>rd</sup> through the 97<sup>th</sup> stories were being heated both by the hot gases from below and by thermal radiation from the fires on the floor above (Figure 2–11). On the south side of the building, where the fires were heating the long-span trusses whose SFRM had been dislodged, the floors began to sag. In so doing, they began pulling inward on their connections to the south face and to the core columns. Pull-in forces due to the sagging floors did not fail the floor connections in most areas.

**Figure 2-11. Temperature contours (°C) on the top and bottom faces of the concrete slab (96<sup>th</sup> floor, WTC 1) at 100 min after impact. A portion of the concrete slab on the north face (top) was damaged by the impact of the aircraft.**

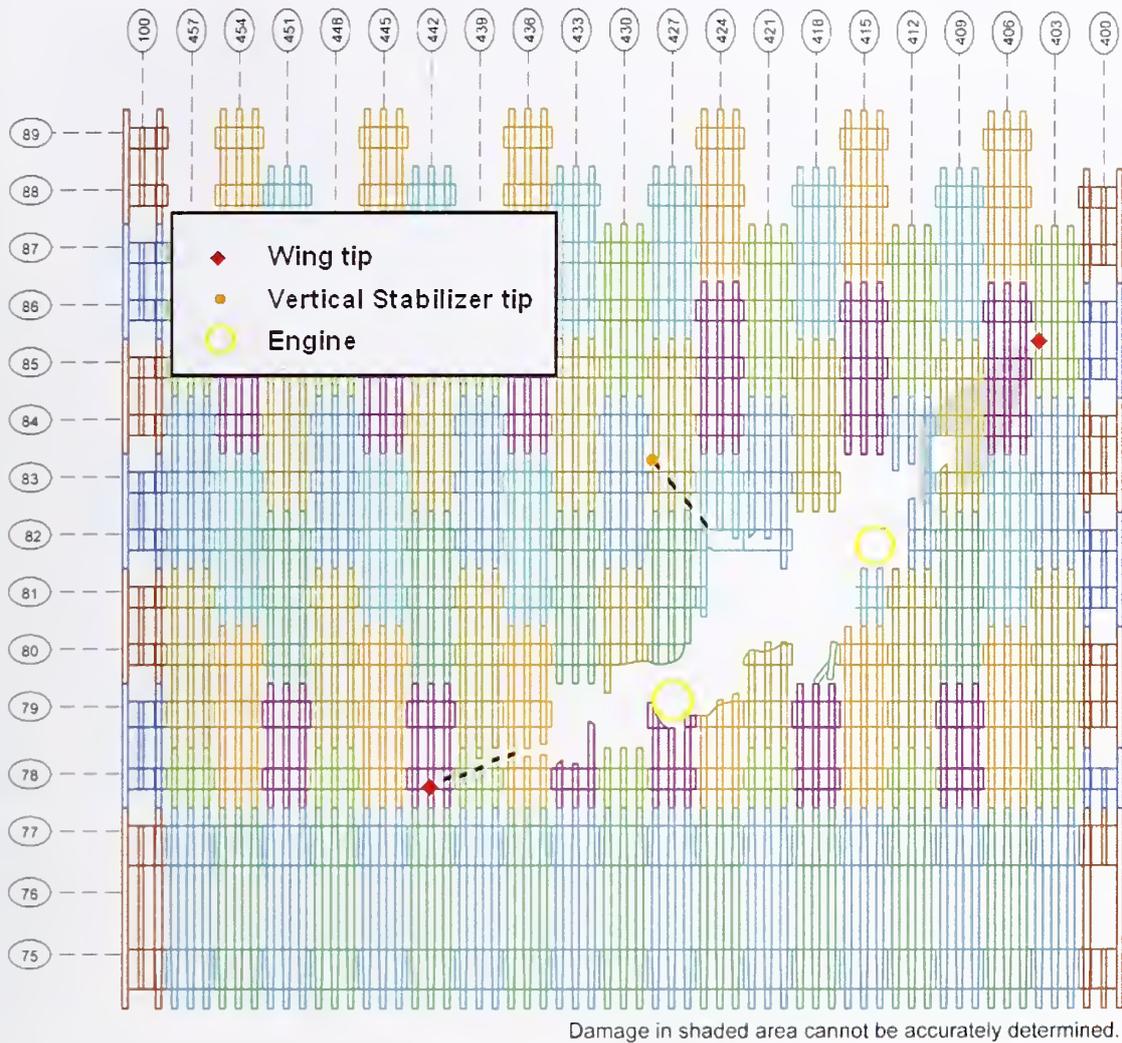
bank angle was steeper than that of AA Flight 11, this entry wound stretched over nine floors, from 77 to 85, rather than eight in WTC 1 (Figure 3–2). The occupancy of those floors is shown in Table 3–1.

Figure 3–2. South face damage of WTC 2 with key aircraft component locations marked.

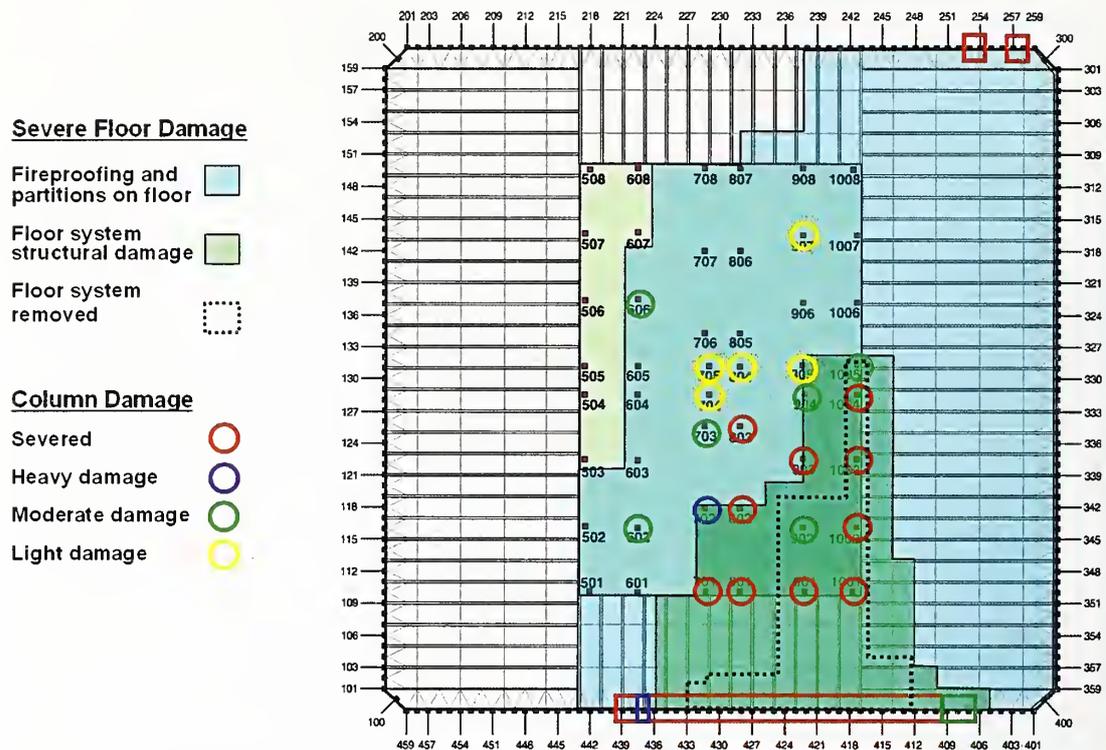
and aluminum sheet of the wing did little damage to the building structure or the SFRM on the columns and trusses on these floors. There were 433 broken windows on the north, east, and south facades.

**Figure 3–3. Simulation of aircraft impact damage to the 78<sup>th</sup> through 83<sup>rd</sup> floors in WTC 2.**

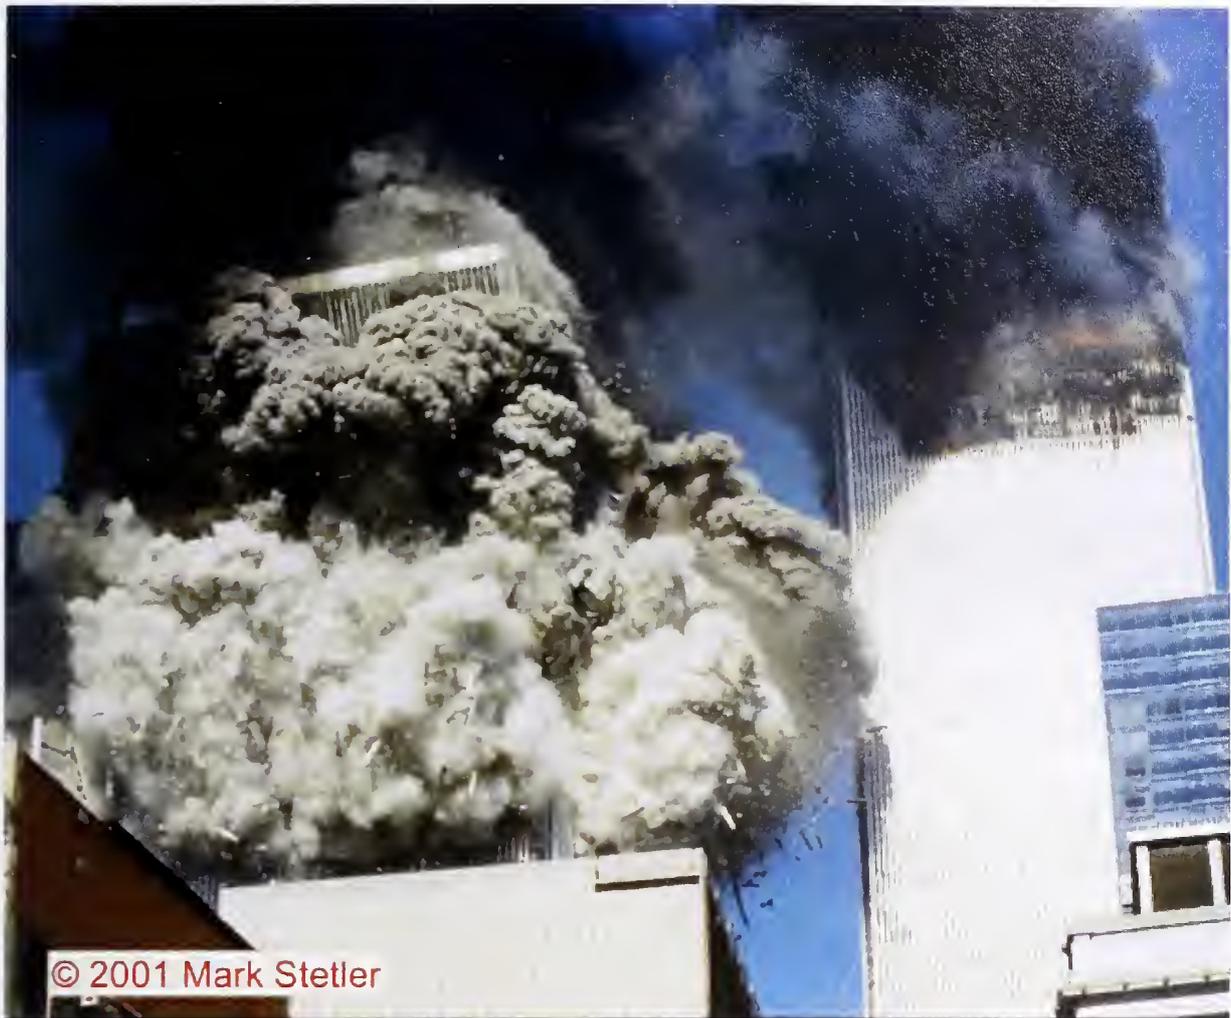
The physical condition of the tower had deteriorated seriously. The inward bowing of columns on the east wall spread along the east face. The east wall lost its ability to support gravity loads, and, consequently, redistributed the loads to the weakened core through the hat truss and to the adjacent north and south walls through the spandrels. But the loads could not be supported by the weakened structure, and the entire section of the building above the impact zone began tilting as a rigid block to the east and south (Figure 3–5). Column failure continued from the east wall around the corners to the north and south faces. The top of the building continued to tilt to the east and south, as, at 9:58:59 a.m., WTC 2 began to collapse.

Figure 3–5. Photograph of WTC 2 tilting to the southeast at the onset of collapse.

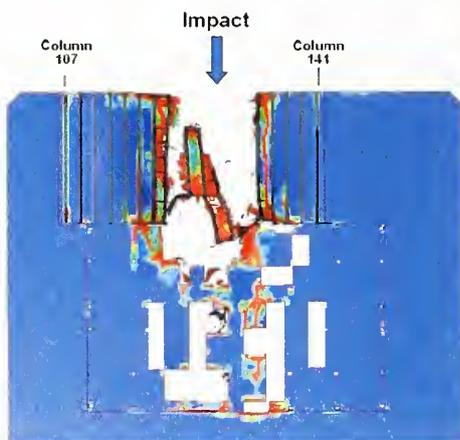
Figure 6–20. Case B damage to the slab of floor 96 of WTC 1.

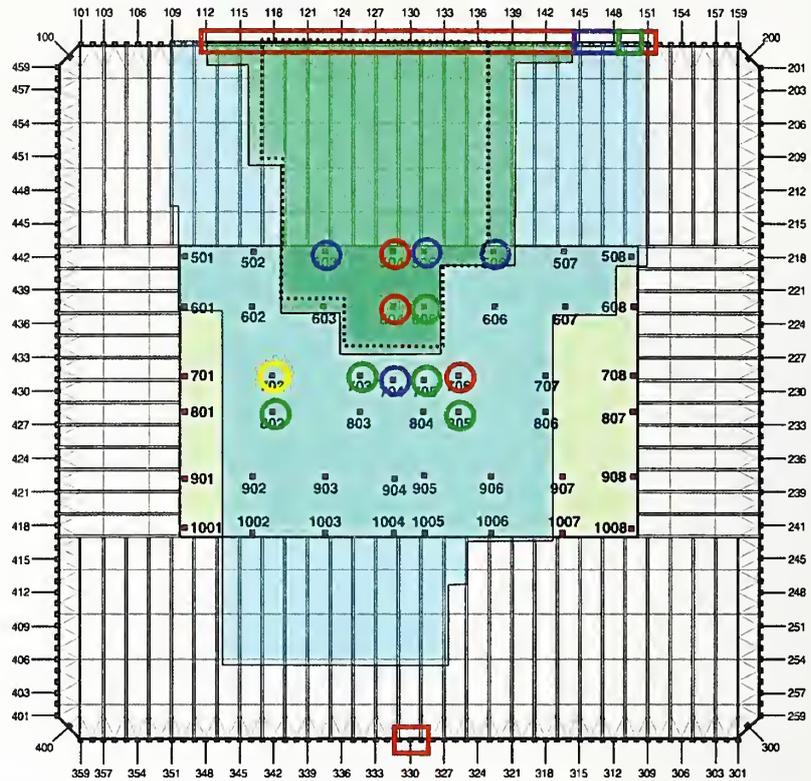
Figure 6–22. Combined structural damage to the floors and columns of WTC 1, Case A.

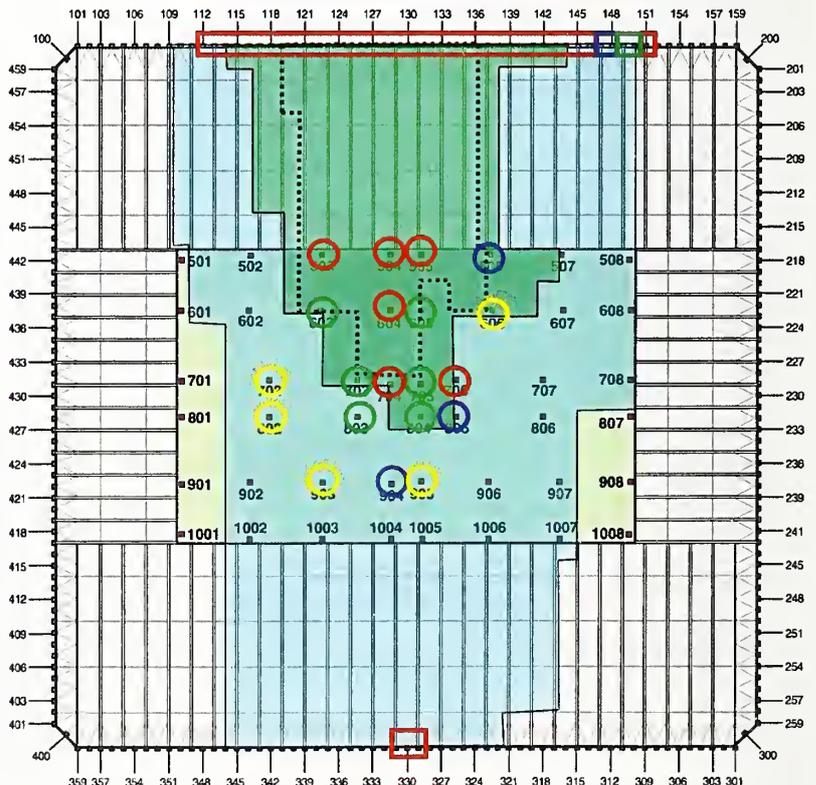
Figure 6–23. Combined structural damage to the floors and columns of WTC 1, Case B.

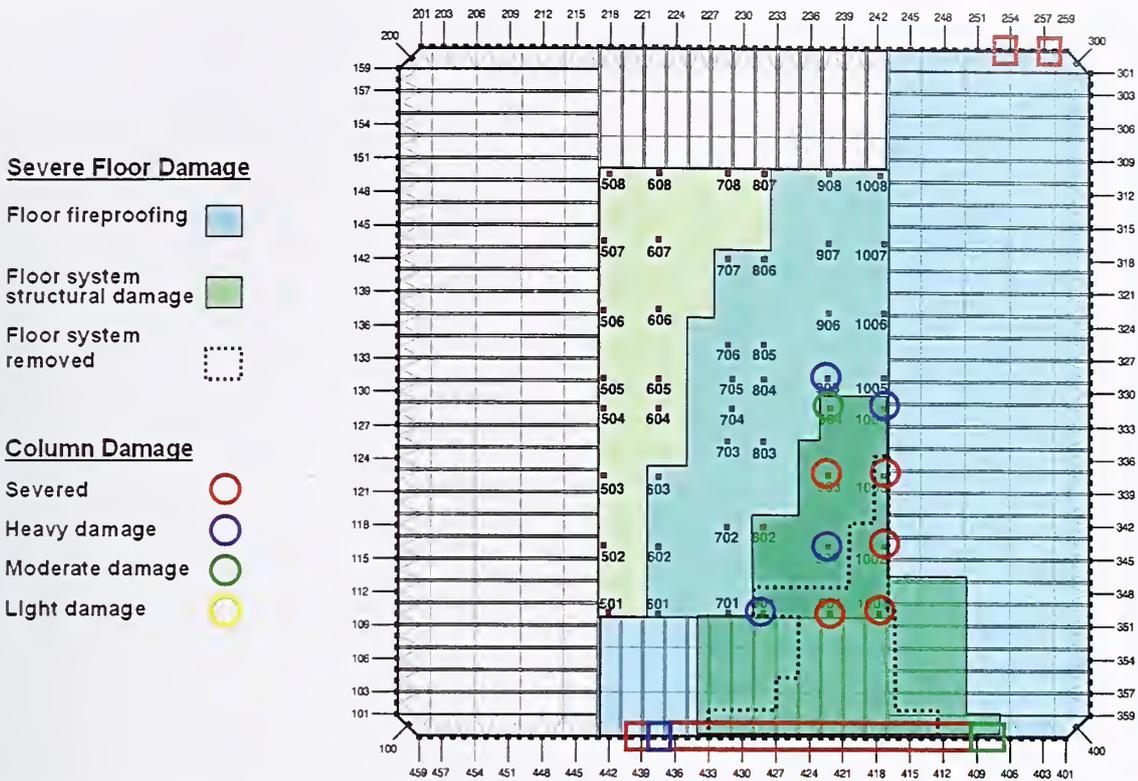
Figure 6-24. Combined structural damage to the floors and columns of WTC 2, Case C.

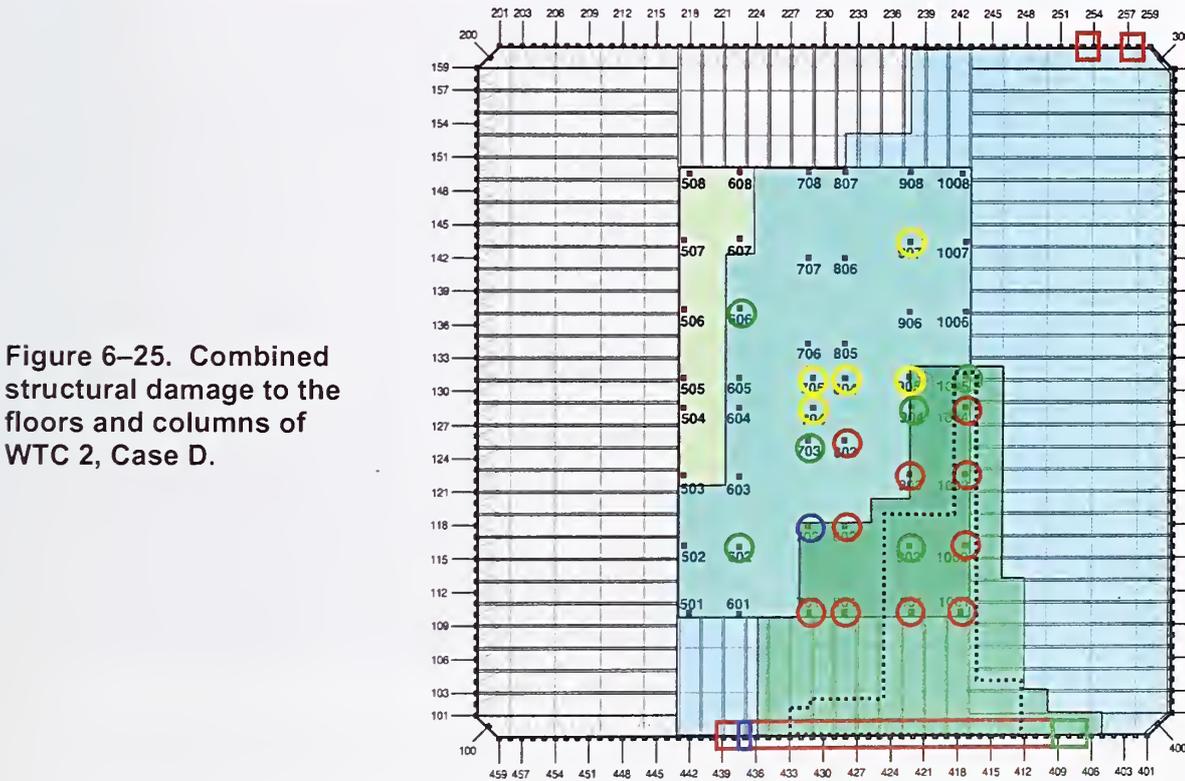
Figure 6-25. Combined structural damage to the floors and columns of WTC 2, Case D.

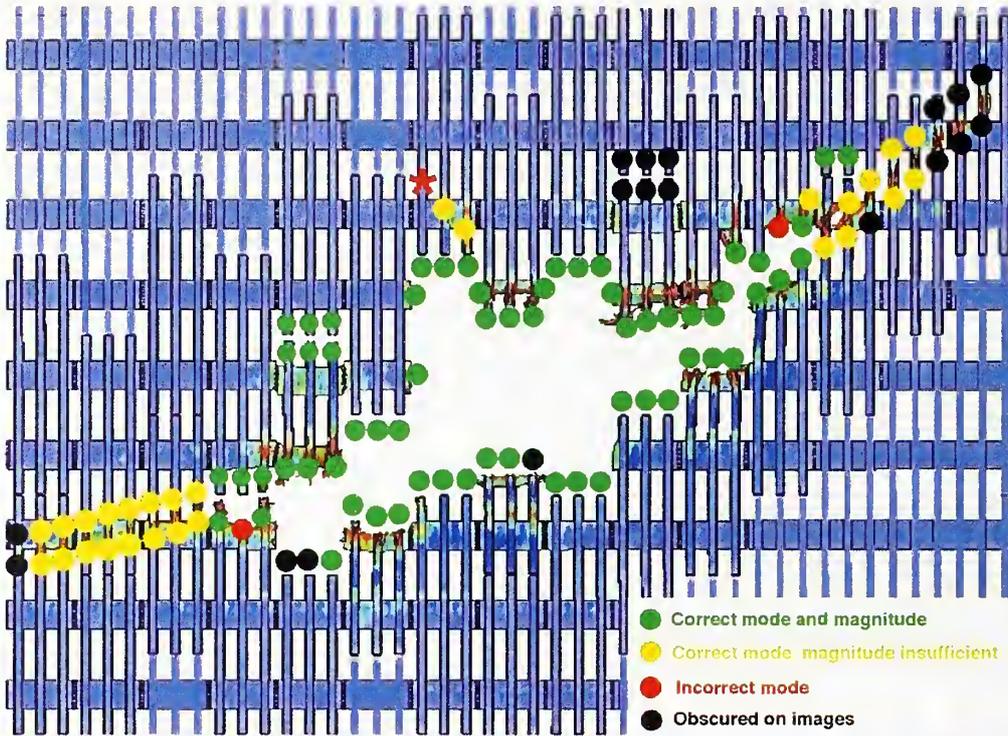
Figure 6–27. Schematic of observed damage (top) and Case A calculated damage (lower) to the north face of WTC 1.

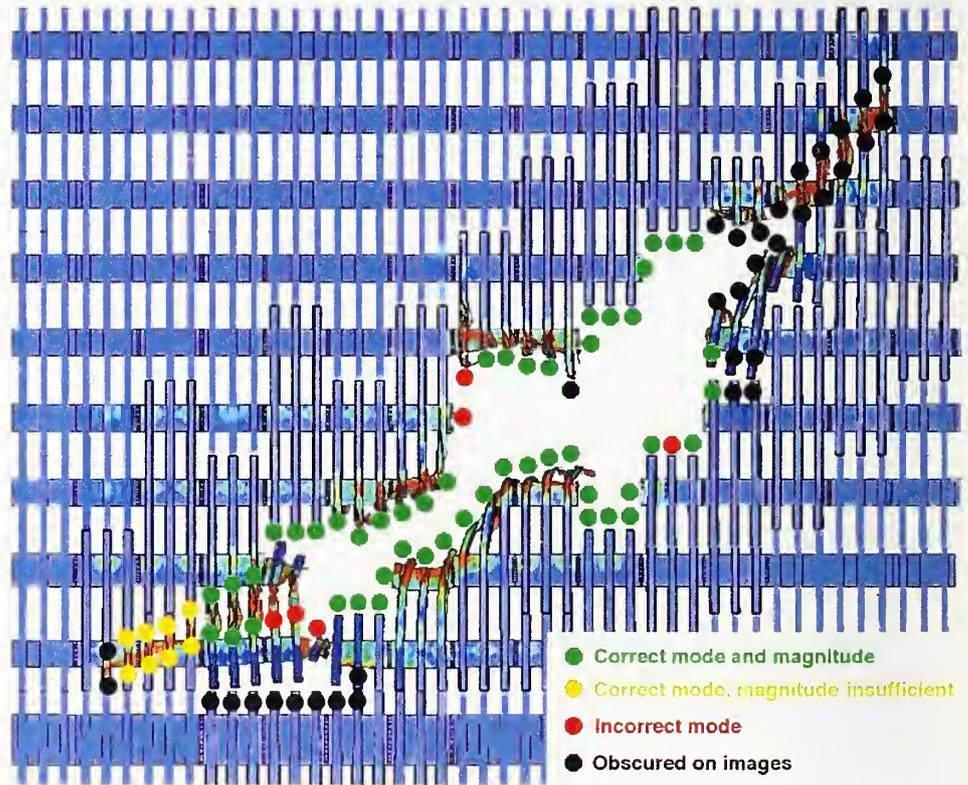
Figure 6–28. Schematic of observed damage (above) and Case C calculated damage (right) to the south face of WTC 2.

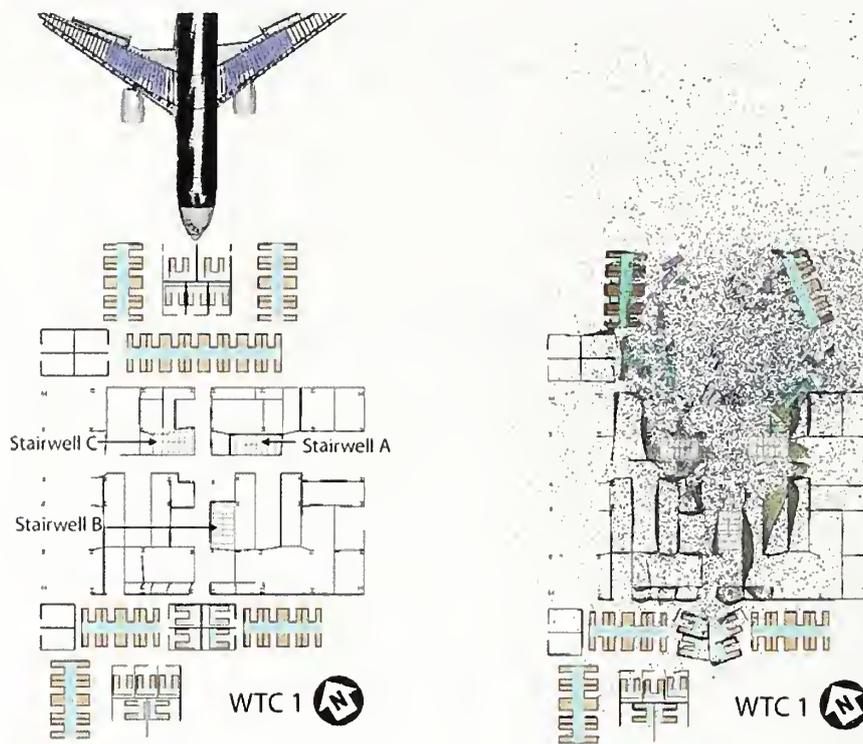
Figure 7-1. Simulated impact damage to 95<sup>th</sup> floor of WTC 1, including stairwells, 0.7 s after impact.

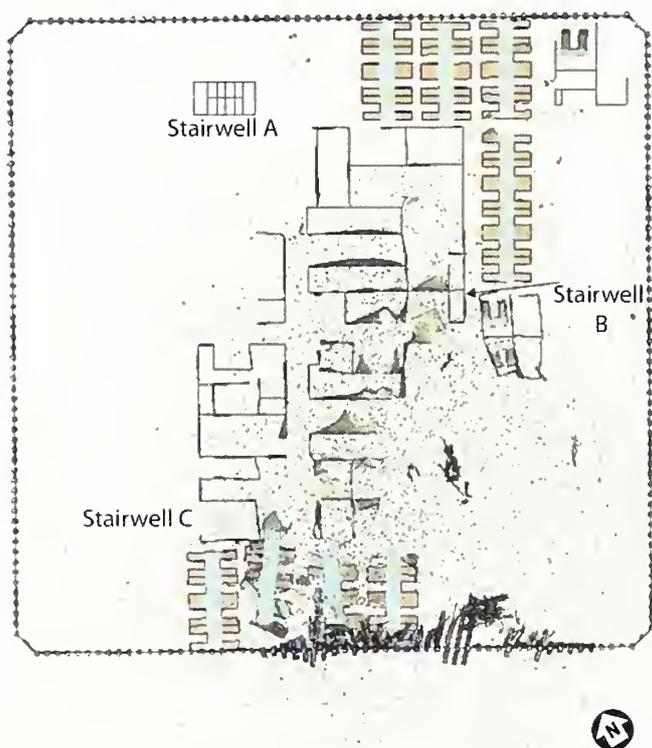
Figure 7-2. Simulated impact damage to WTC 2 on floor 78, 0.62 s after impact.
