**NIST NCSTAR 1**

# **Final Report** on the **Collapse of** **the World Trade Center Towers**

**National Institute of  
Standards and Technology**

September 2005

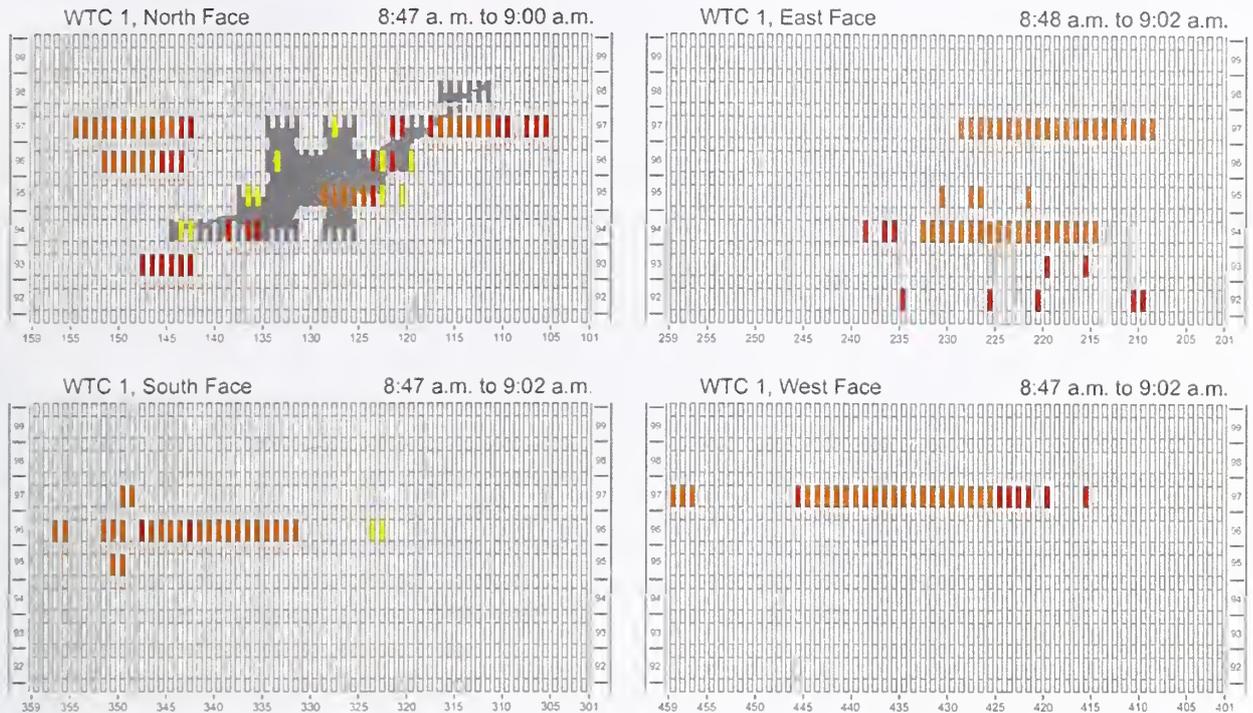
The burning of the jet fuel cloud had consumed much of the oxygen within the 94<sup>th</sup> and 96<sup>th</sup> floors, although photographs showing survivors indicated there were some zones with breathable air. The oxygen-starved fires died down, but didn't quite go out. Within the first 2 min after the impact, fires could be seen in the north side windows on the 93<sup>rd</sup> through 97<sup>th</sup> floors, the 96<sup>th</sup> floor of the south face, and the 94<sup>th</sup> floor of the east face. As fresh air entered the perforated facades, there began the steady burning of the office furnishings and the 13 tons of combustibles from the aircraft that would eventually overwhelm the already damaged building. By 9:00 a.m., these fires had grown and spread to the extent shown in Figure 2-5. In addition to burning around the aircraft entrance hole, there was intense burning on the north, east, and west faces of the 97<sup>th</sup> floor. Large fires burned on the south side of the 96<sup>th</sup> floor and the east side of the 94<sup>th</sup> floor. At 8:52 a.m., a stream of smoke emerged from the south side of the 104<sup>th</sup> floor, although there was no evidence of a significant fire there yet.

**Figure 2-5. Representation of exterior views of the fires on the four faces of WTC 1 from 8:47 a.m. to about 9:02 a.m.**

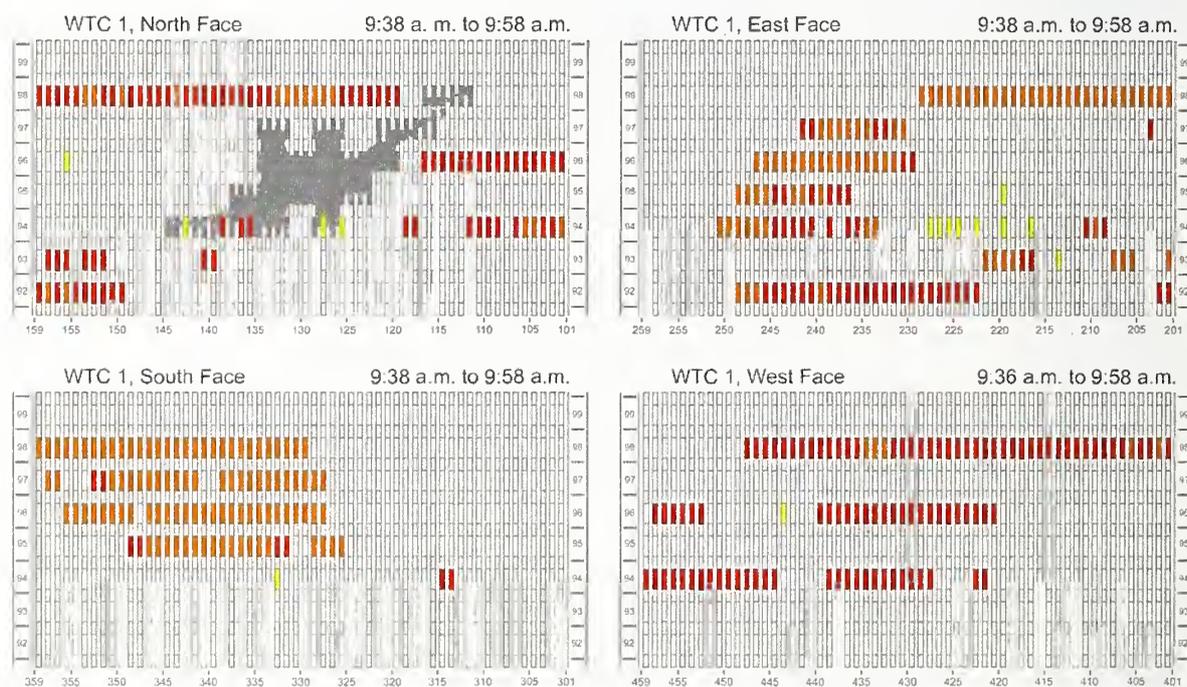
Seventy-five minutes after the impact, approaching 10:00 a.m., the fire on the 97<sup>th</sup> floor had begun to burn itself out, but the fire on the 94<sup>th</sup> floor had intensified and filled much of the north half of the floor (Figure 2–7). Starting about 9:30 a.m., there were vigorous fires on nearly the full perimeter of the 98<sup>th</sup> floor. There was still almost no burning on the 99<sup>th</sup> floor or above.

**Figure 2–7. Representation of exterior views of the fires on the four faces of WTC 1 from about 9:38 a.m. to 9:58 a.m.**

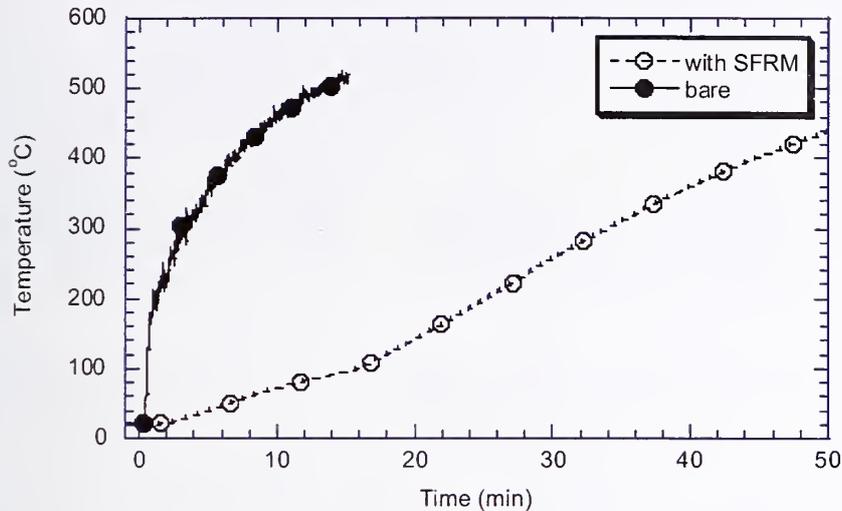
The perimeter columns, floors, and core columns were immersed in these hot gases and began to weaken. Where the insulation was dislodged, the temperature of the steel rose rapidly, in contrast to steel members where insulation was intact (Figure 2–8). The heaviest core columns with damaged insulation heated slowly, as the absorbed heat was dissipated through their massive cross sections. The temperatures of the lighter columns and the floor slabs rose more quickly, and those of the stripped trusses even more so.

**Figure 2–8. Steel surface temperatures on the bottom chords of fire-exposed trusses, uninsulated and insulated with ¾ in. of BLAZE-SHIELD DC/F.**

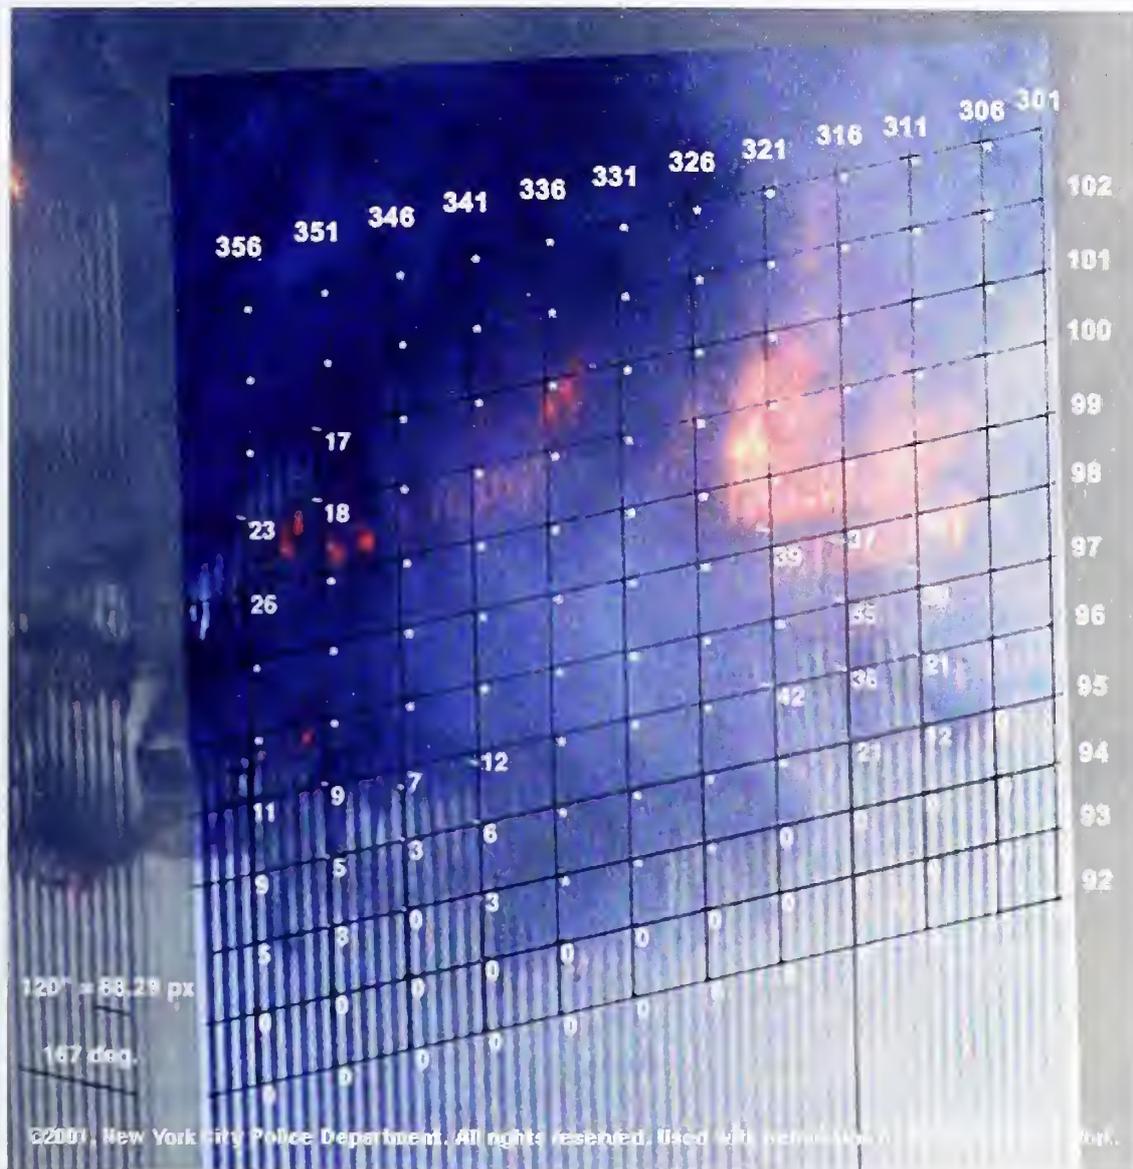
The sagging of the floors had increased. Although the floors on the north side of the tower had sagged first, they contracted due to cooling when the fires moved toward the south. Now, the south side floors had sagged to the point where the south perimeter columns bowed inward (Figure 2–12). By 10:23 a.m., the south exterior wall had bowed inward as much as 55 in.

**Figure 2–12. South face of WTC 1 at 10:23 a.m., showing inward buckling (in inches) of perimeter columns.**

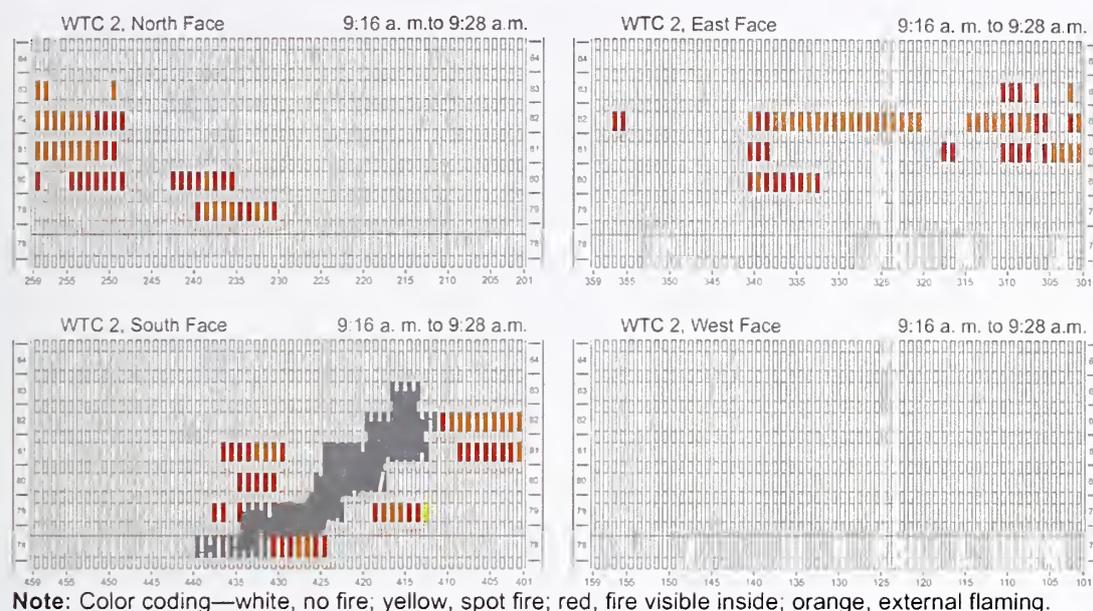
For the next half hour, small fires were burning in and near the aircraft impact cavity on the south side of the building. There were vigorous fires on the east side of the 80<sup>th</sup> through 83<sup>rd</sup> floors (Figure 3–4), especially on the northeast end of the 81<sup>st</sup> and 82<sup>nd</sup> floors, where the aircraft had bulldozed the office desks and chairs and added its own combustibles. In addition to the ample supply of fuel, these fires had access to plenty of air, as numerous windows on the east face had been blown out by the impact or fireball. They would continue to burn as long as the building stood.

**Figure 3–4. Representation of exterior views of the fires on the four faces of WTC 2 at about 9:20 a.m.**

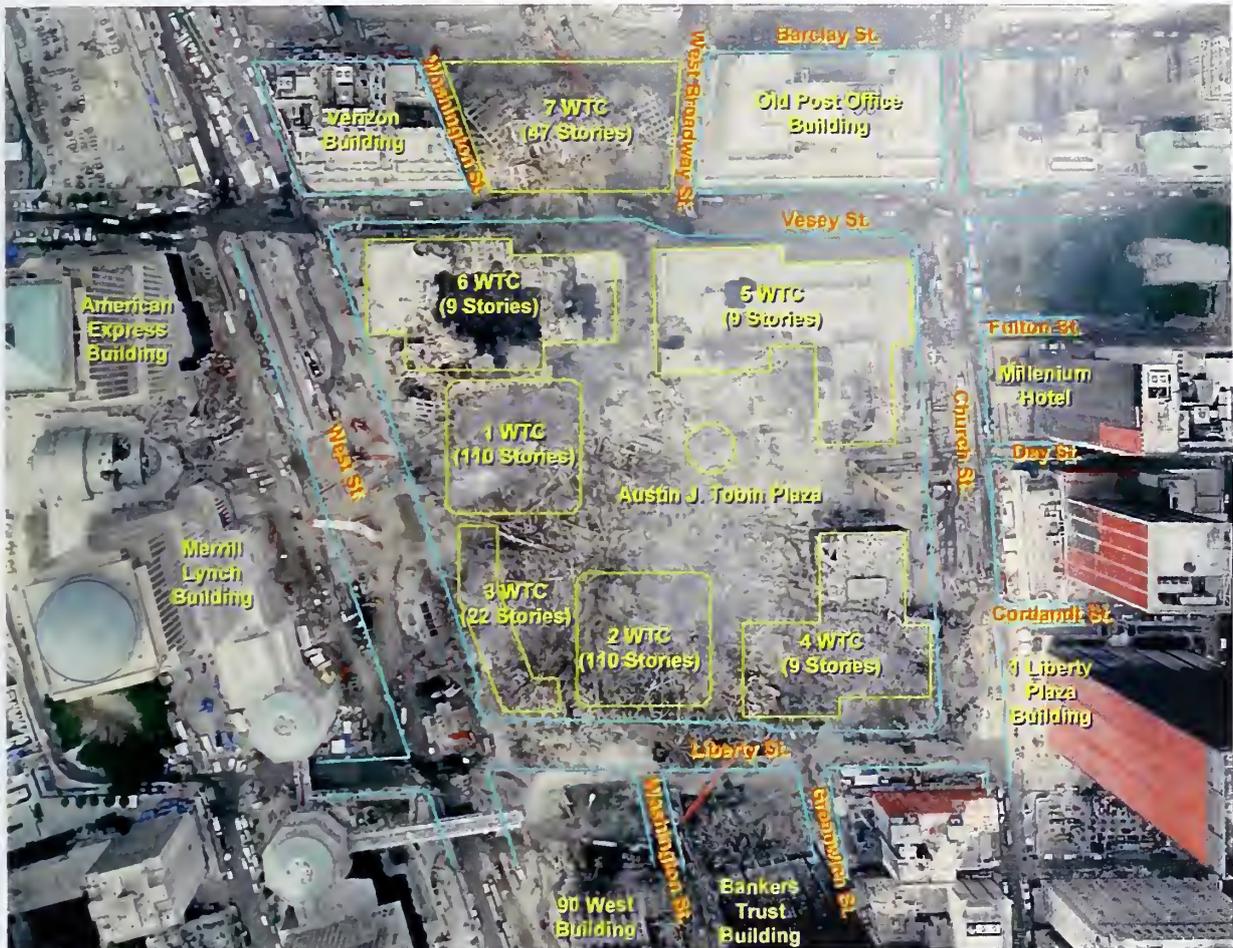
By sunset on September 11, 2001, all seven buildings on the World Trade Center (WTC) site lay in ruins (Figure 4-1). Table 4-1 compiles the likely locations of the decedents.

Figure 4-1. The WTC site on September 17, 2001.

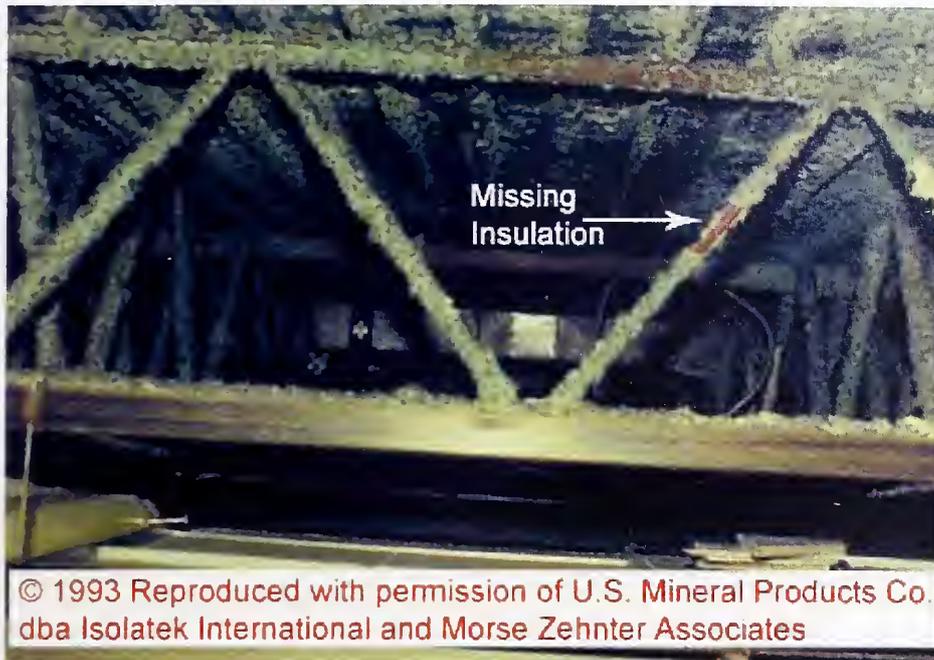
In 1994, The Port Authority measured the SFRM thickness on trusses on floors 23 and 24 of WTC 1. In all, average thicknesses were reported for 32 locations, and the overall average thickness was found to be 0.74 in. NIST performed a further evaluation of the SFRM thickness using photographs taken in the 1990s of floor trusses on (non-upgraded) floors 22, 23, and 27 of WTC 1 (Figure 5-5). By measuring dimensions on the photographs, NIST estimated the insulation thicknesses on the diagonal web members of trusses. (The thickness of chord member insulation could not be measured.) The average thickness and standard deviation of web members was 0.6 in. ± 0.3 in. on the main trusses, 0.4 in. ± 0.25 in. on the bridging trusses, and 0.4 in. ± 0.2 in. on the diagonal struts. These numbers indicated that there were areas where the coating thickness was less than the specified 0.5 in.

**Figure 5–5. Irregularity of coating thickness and gaps in coverage on SFRM-coated bridging trusses.**

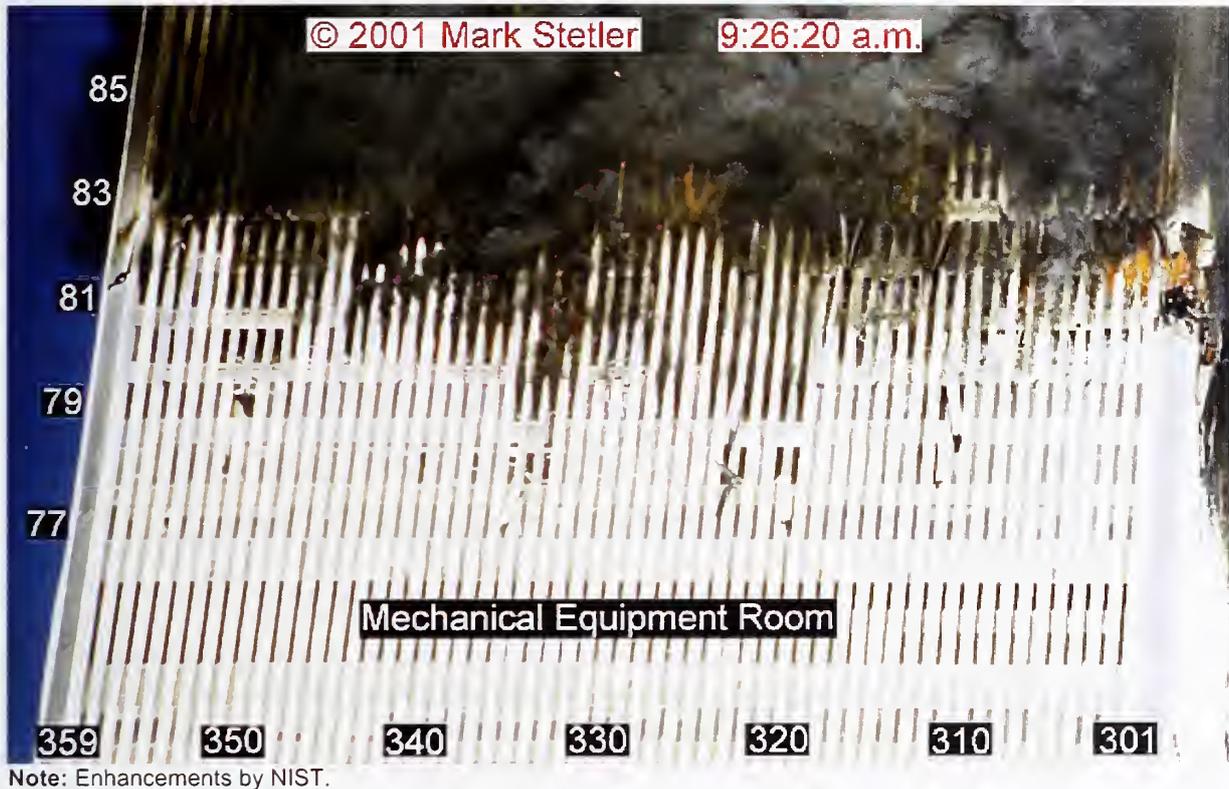
As an example of information that was extracted, Figure 6–1 shows an enhanced image of the east face of WTC 2. Figure 6–2 expands a section of interest. The amount of detail available is evident. For instance, large piles of debris are present on the north side of the tower on the 80<sup>th</sup> and 81<sup>st</sup> floors, and locations where fires are visible or where missing windows are easily identified. Many details of each frame were important in tracking the evolution of the fires and the damage to the buildings.

Figure 6–1. 9:26:20 a.m. showing the east face of WTC 2.

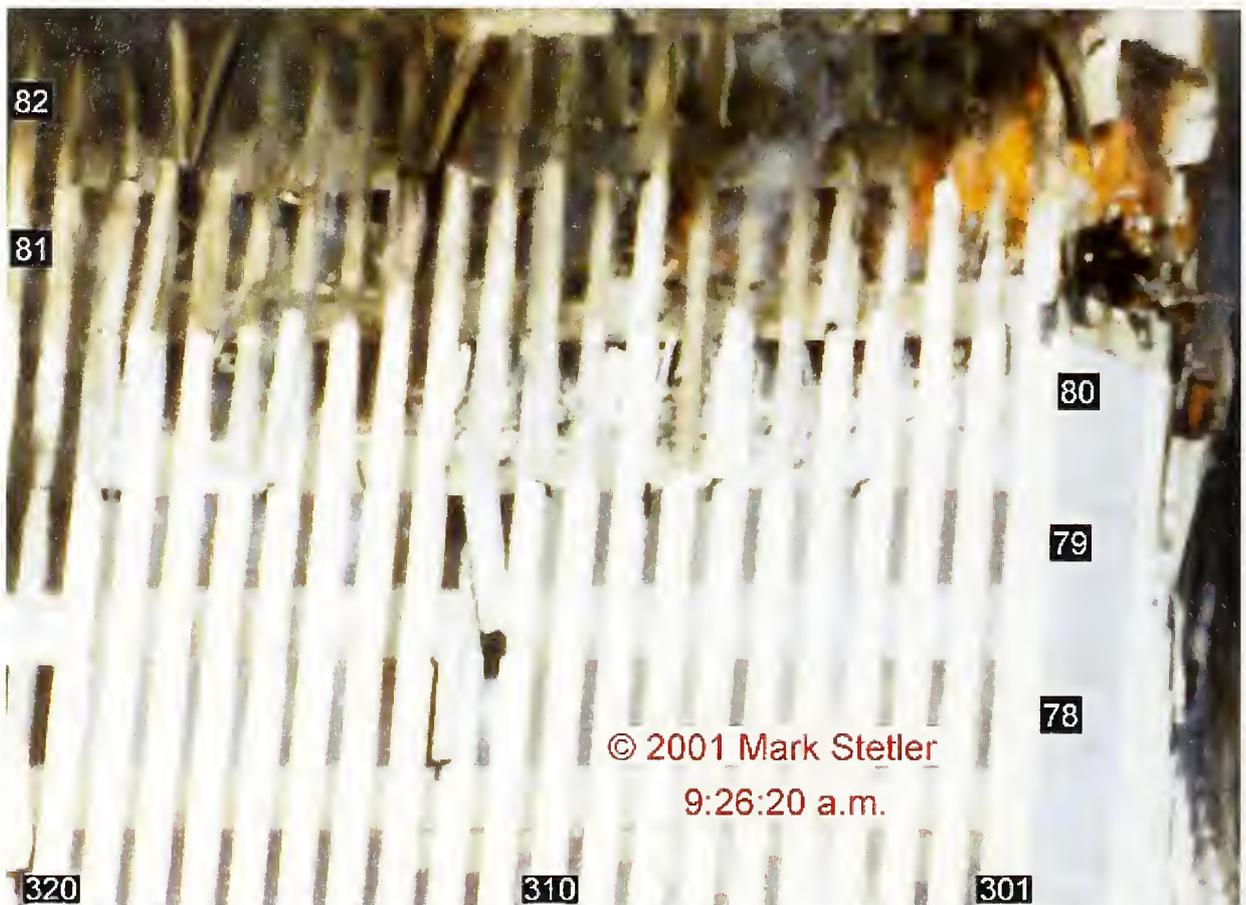
Figure 6–2. Close-up of section of Figure 6–1.

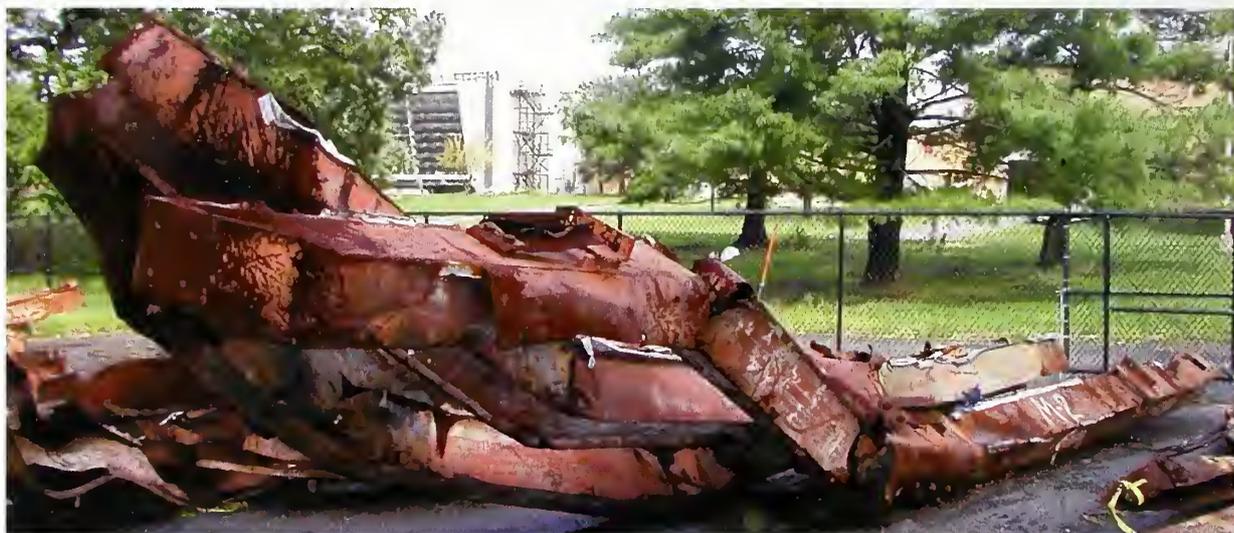
**Figure 6–4. WTC 1 exterior panel hit by the fuselage of the aircraft.**

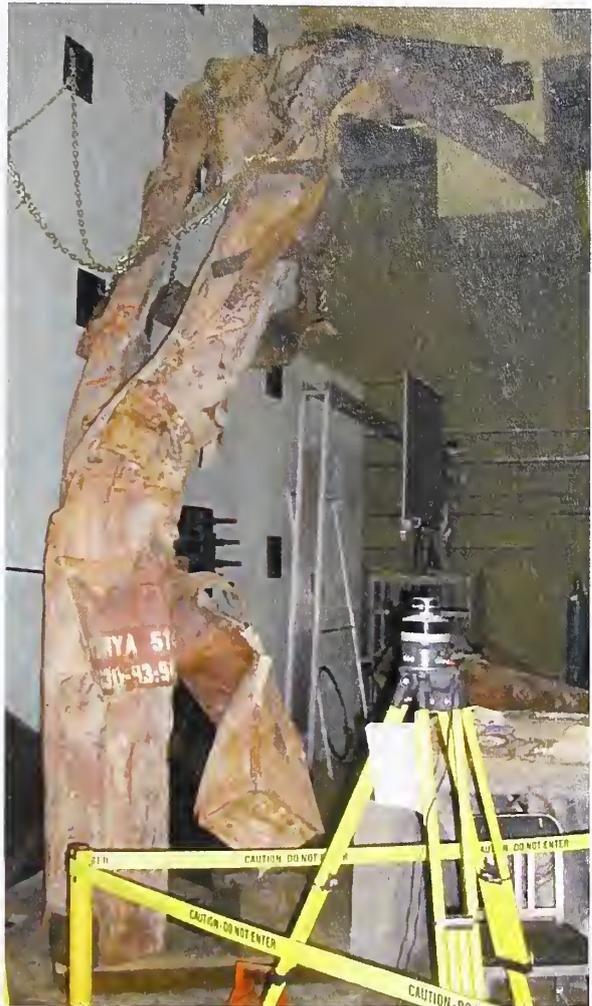
**Figure 6–5. WTC 1 exterior panel hit by the nose of the aircraft.**

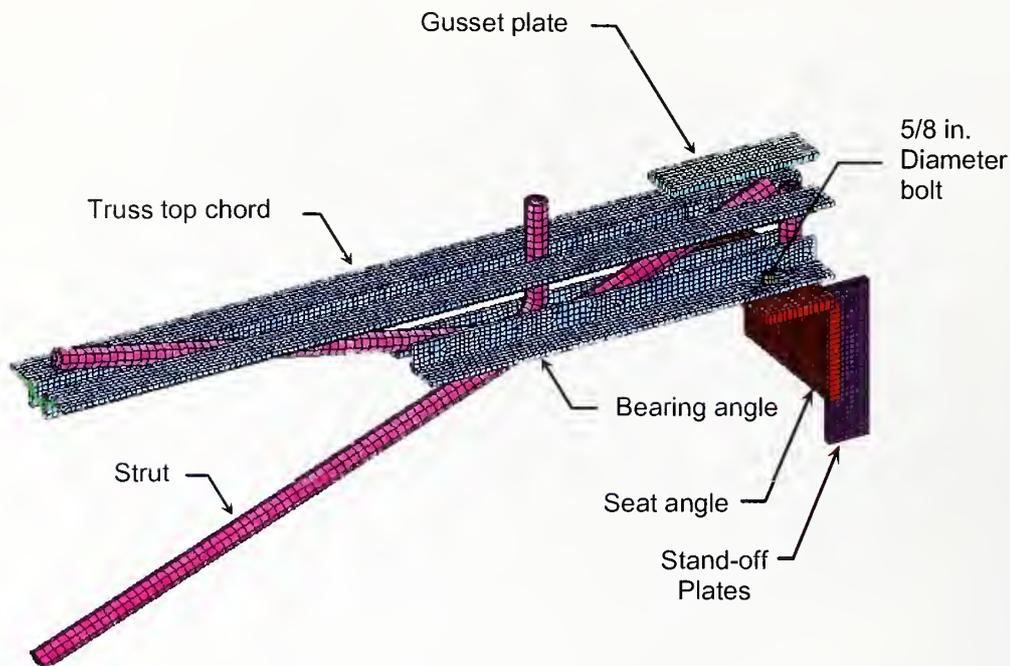
- **Truss seats.** Figure 6–10 shows how an exterior seat connection was represented in the finite element structural model. The component analysis determined that failure could occur at the bolted connection between the bearing angle and the seat angle, and the truss could slip off the seat. Truss seat connection failure from vertical loads was found to be unlikely, since the needed increase in vertical load was unreasonable for temperatures near 600 °C to 700 °C.
- **Knuckles.** The “knuckle” was formed by the extension of the truss diagonals into the concrete slab and provided for composite action of the steel truss and concrete slab. A model was developed to predict the knuckle performance when the truss and concrete slab acted compositely.

**Figure 6–10. Finite element model of an exterior truss seat.**

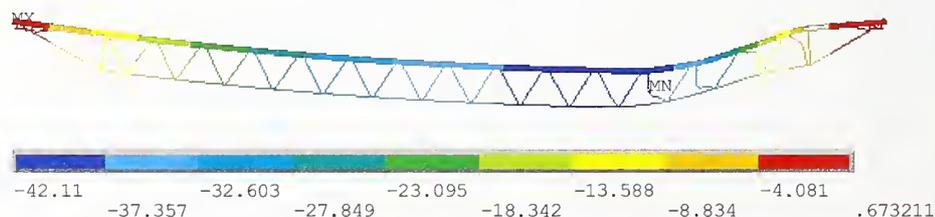
- Single composite truss and concrete slab section. A floor section was modeled to investigate failure modes and sequences of failures under combined gravity and thermal loads. The floor section was heated to 700 °C (with a linear thermal gradient through the slab thickness from 700 °C to 300 °C at the top surface of the slab) over a period of 30 min. Initially the thermal expansion of the floor pushed the columns outward, but with increased temperatures, the floor sagged and the columns were pulled inward. Knuckle failure was found to occur mainly at the ends of the trusses and had little effect on the deflection of the floor system. Figure 6–11 shows that the diagonals at the core (right) end of the truss buckled and caused an increase in the floor system deflection, ultimately reaching approximately 42 in. Two possible failure modes were identified for the floor-truss section: sagging of the floor and loss of truss seat support.

**Figure 6–11. Vertical displacement at 700 °C.**

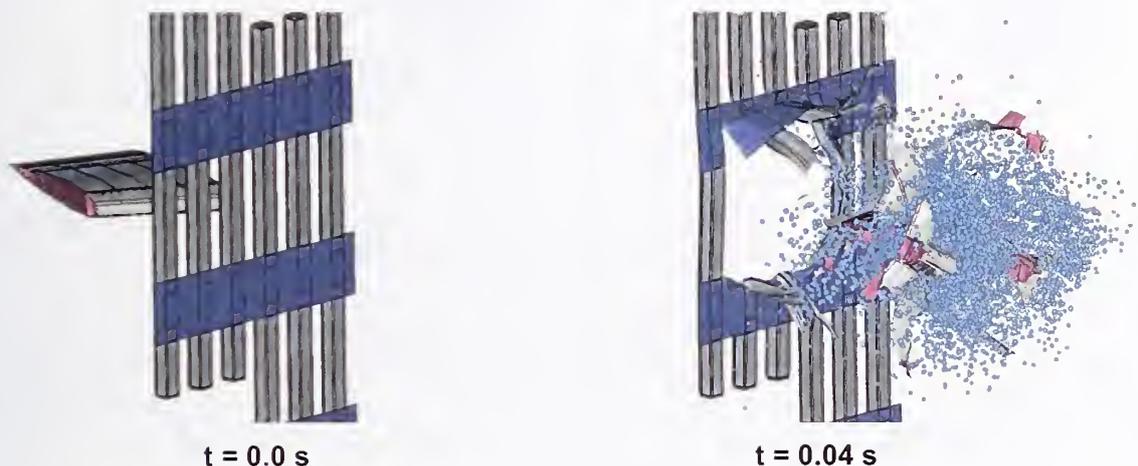
Figure 6–16 shows two frames from the last of these analyses, with the wing segment entering from the left, being fragmented as it penetrates the exterior columns, and spraying jet fuel downstream.

**Figure 6–16. Calculated impact on an exterior wall by a fuel-laden wing section.**

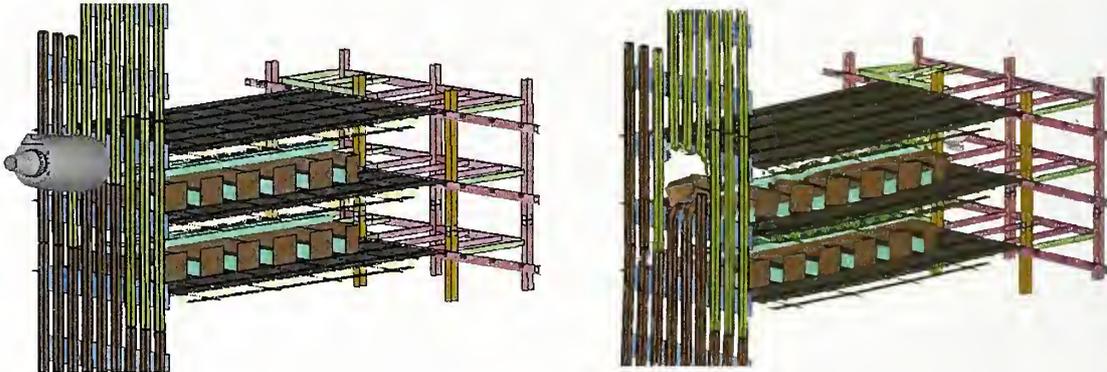
**Figure 6–17. Response of a tower subassembly model to engine impact.**

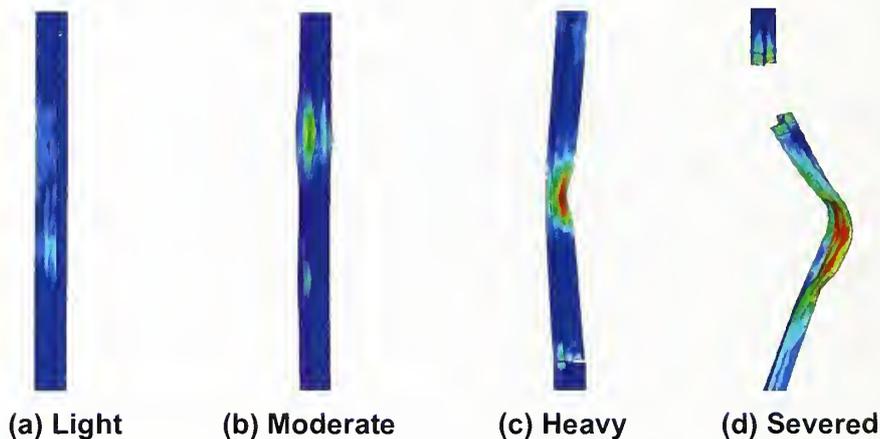
- Lightly damaged column: column impacted, but without significant structural deformation;
- Moderately damaged column: visible local distortion, but no deformation of the column centerline;
- Heavily damaged column: Permanent deflection of the column centerline; and
- Failed column: Column severed.

Figure 6–19. Column damage levels.

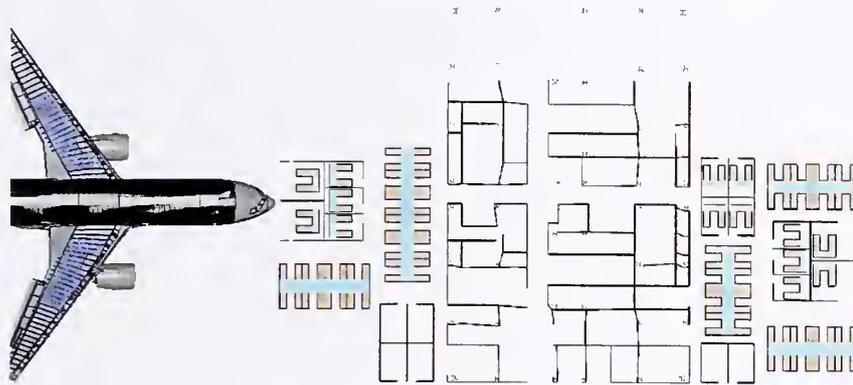
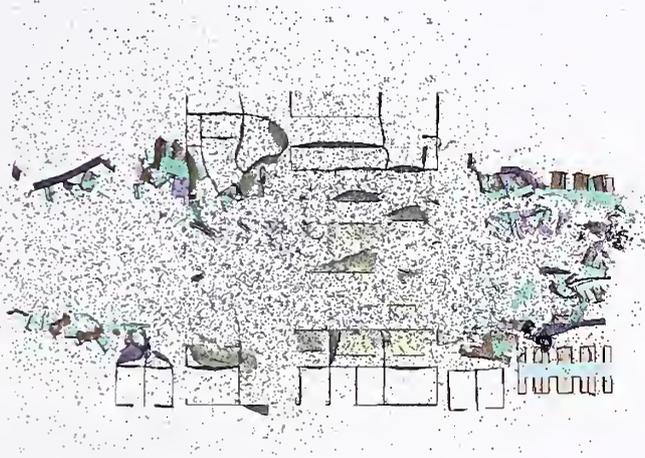
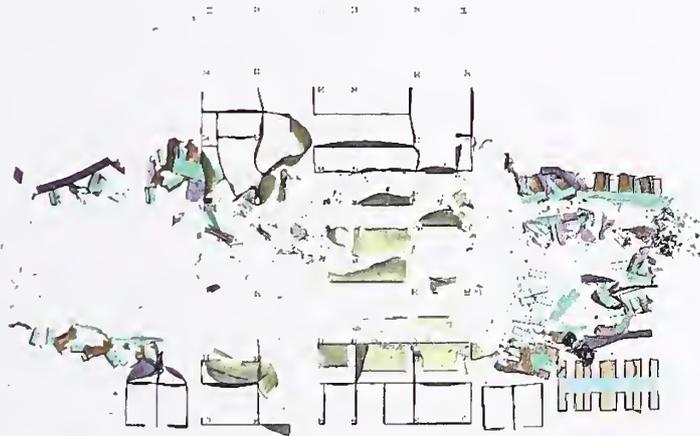
Figure 6–21. Case B simulation of response of contents of 96<sup>th</sup> floor of WTC 1.

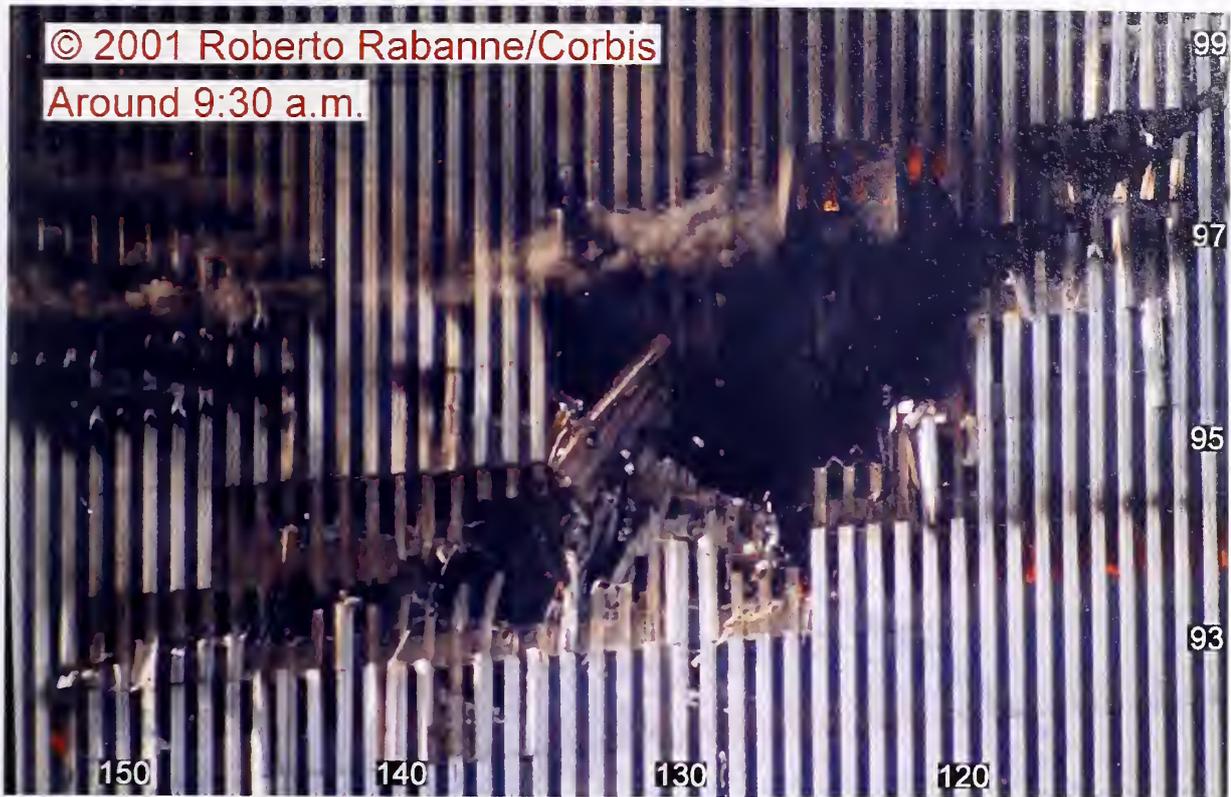
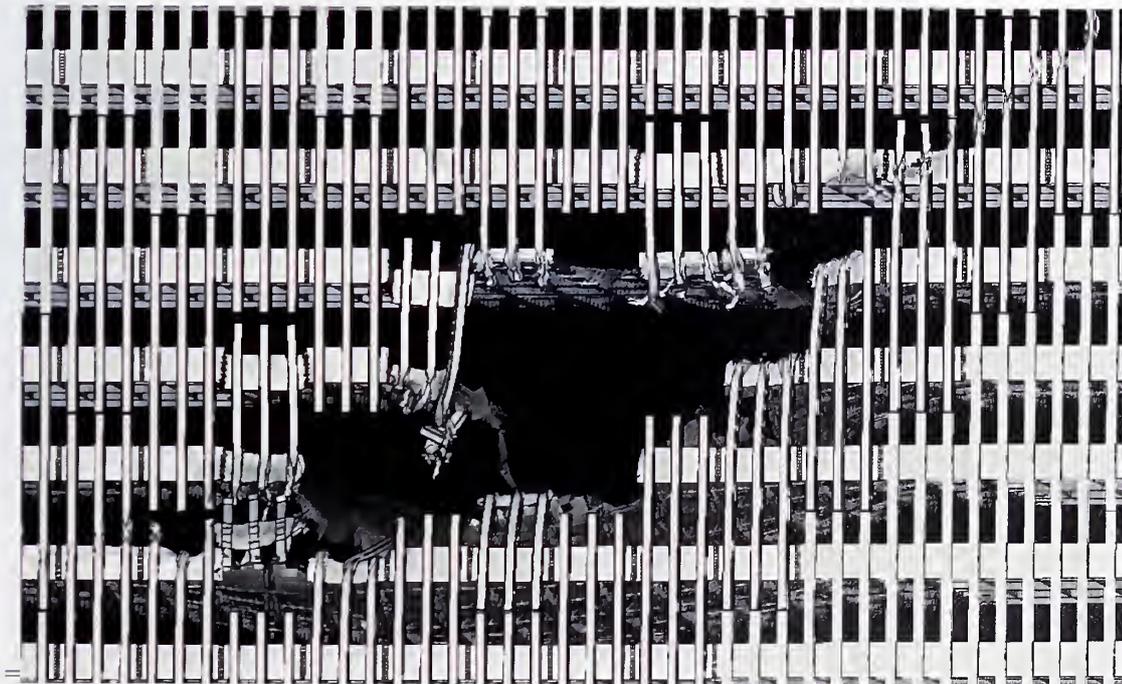
Figure 6–26. Observed and Case A calculated damage to the north face of WTC 1.

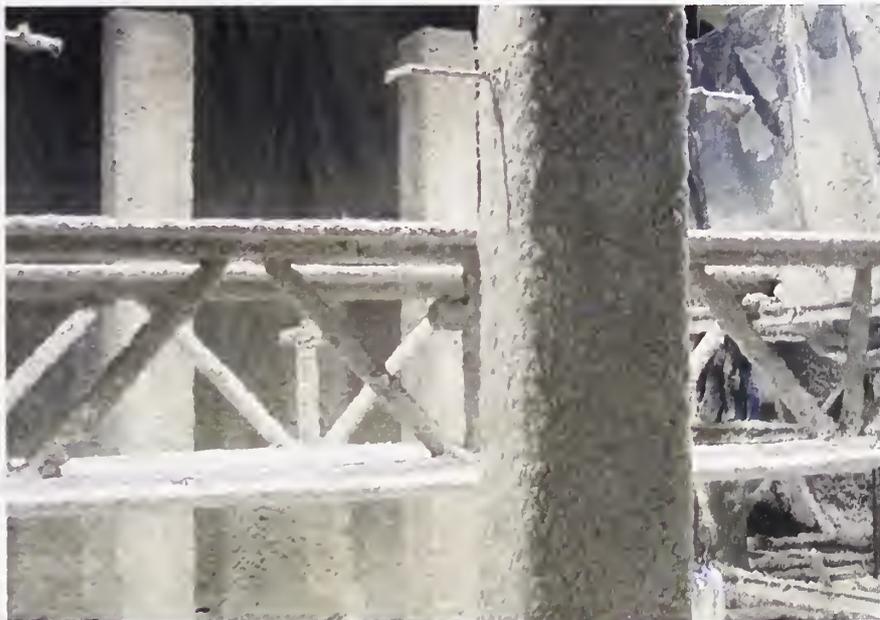
experienced applicator, who took considerable care to apply an even coating of the specified thickness. As such, the insulated test subjects represent a best case in terms of thickness and uniformity. Figure 6-42 shows some of the coated components.

Figure 6-42. SFRM-coated steel components prior to a test.

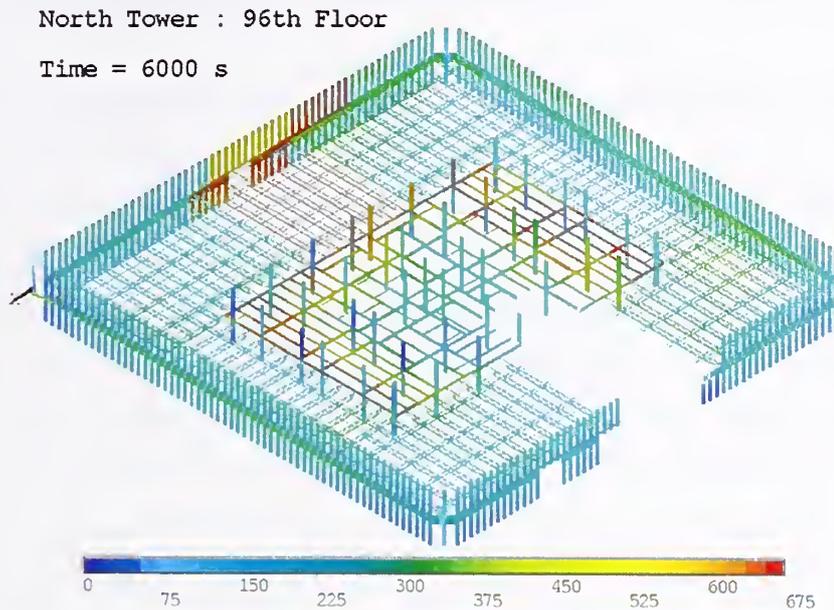
**Figure 6–46. Temperatures (°C) on the columns and trusses of the 96<sup>th</sup> floor of WTC 1 at 6,000 s after aircraft impact, Case B.**

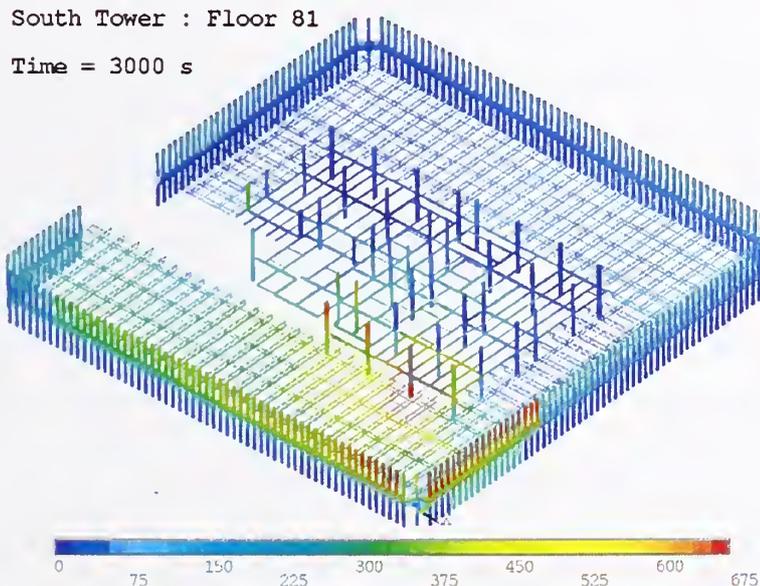
**Figure 6–47. Temperatures (°C) on the columns and trusses of the 81<sup>st</sup> floor of WTC 2 at 3,000 s after aircraft impact, Case D.**

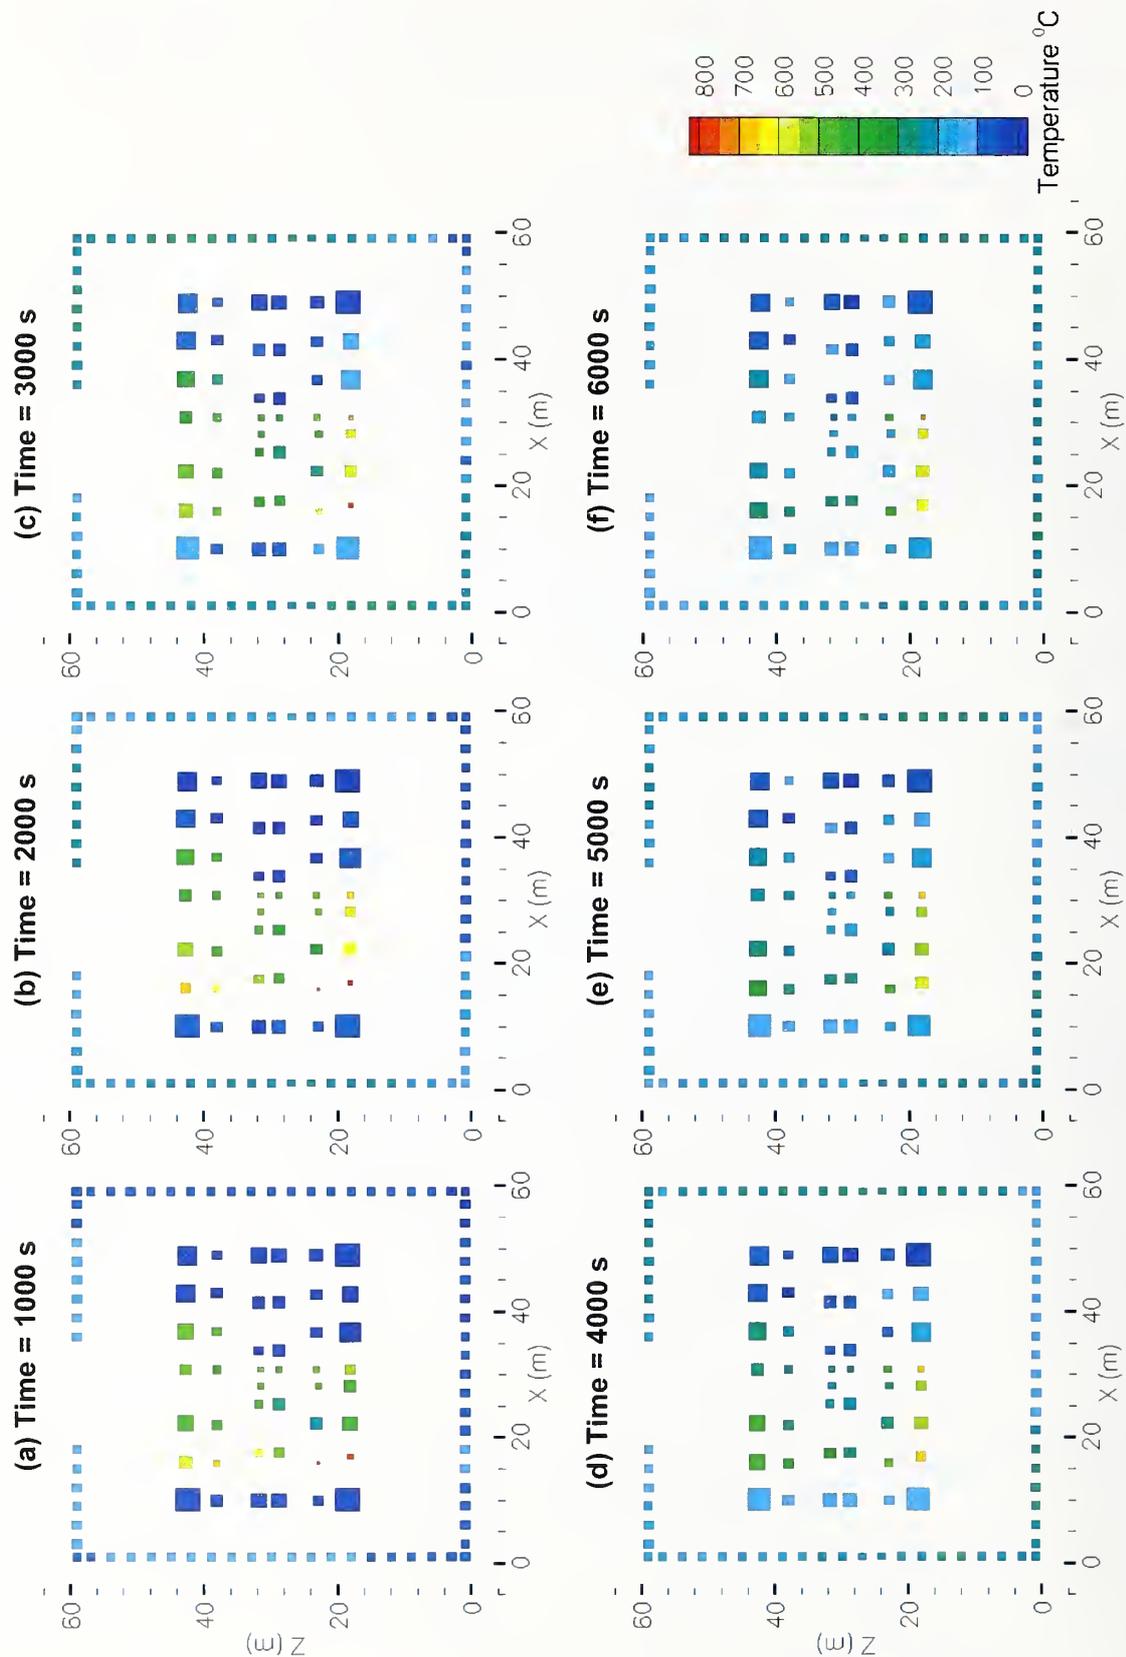
A third visualization tool was animation of the evolving temperatures of the columns. Frames from an example, again of the 96<sup>th</sup> floor of WTC 1, Case A, are shown in Figure 6–48. The size of the square representing a column represents its yield strength. Columns may have been heated when the fire was nearby and then cooled after the local combustibles were consumed.

Figure 6-48. Frames from animation of the thermal response of columns on the 96<sup>th</sup> floor of WTC 1, Case A.

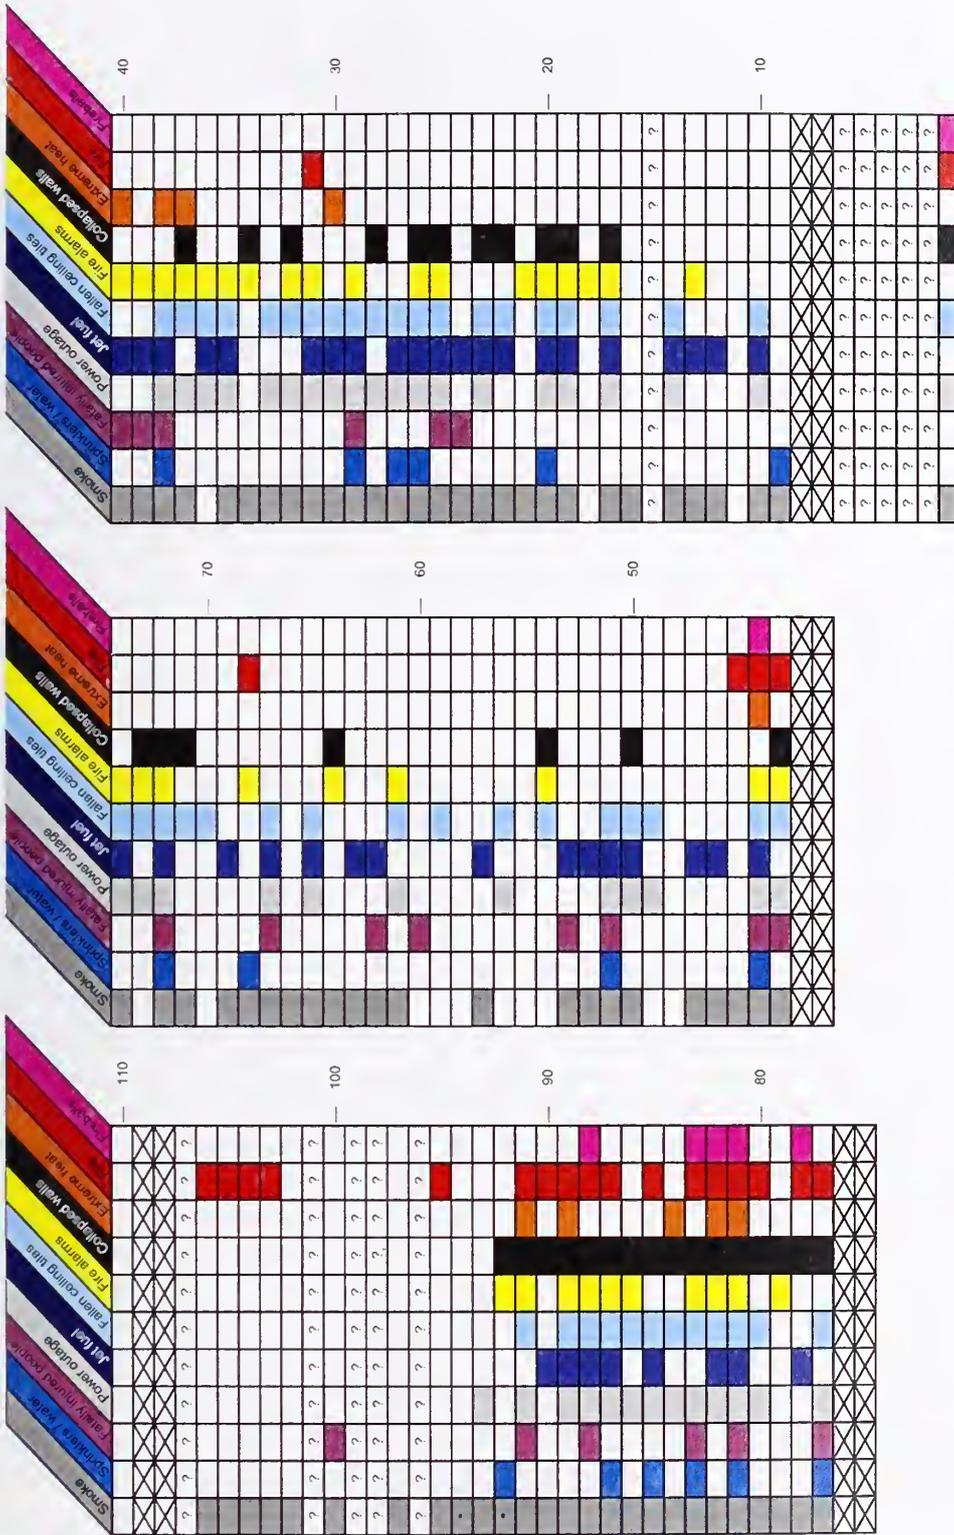
- Occupants throughout the building observed various types of impact indicators throughout the building, including wall, partition, and ceiling damage and fire and smoke conditions. The filled-in squares in Figure 7–3 indicate the floors on which the different observations were reported.

Figure 7-3. Observations of building damage after initial awareness but before beginning evacuation in WTC 1.
